June 6, 2021

Please see the below recommendations as a followup to the July 2020 tree report submitted by GTI. and a list of additional trees for removal or monitoring,

Trees addressed in 2021 report:

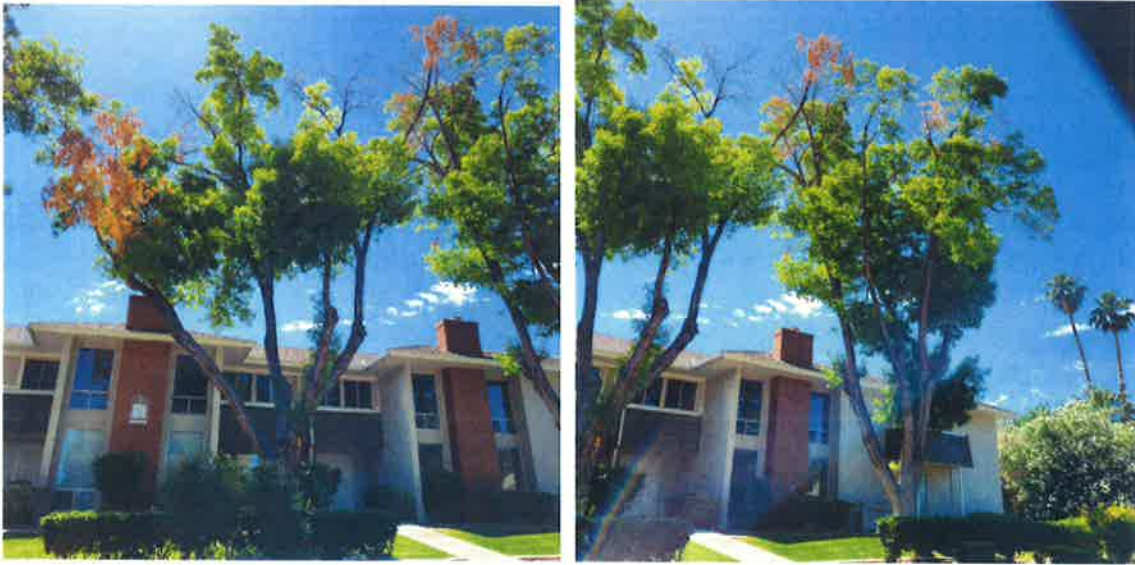
Bldg 1/Tree #1 Arizona Ash: tree health and structure is improving; prune to remove dead limbs,;continue to monitor

Bldg 1/Tree #2 Arizona Ash: tree health and structure is improving; prune to remove dead limbs; continue to monitor

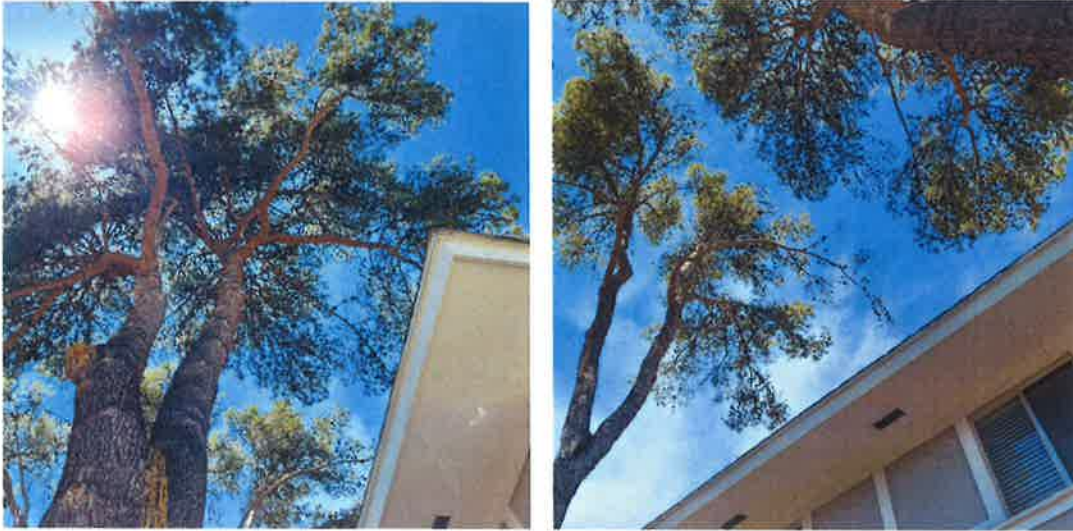
Bldg 7/Trees #3 & 4: Two pine, add emitters (12 per tree as per SNWA recommendations); prune dead branches

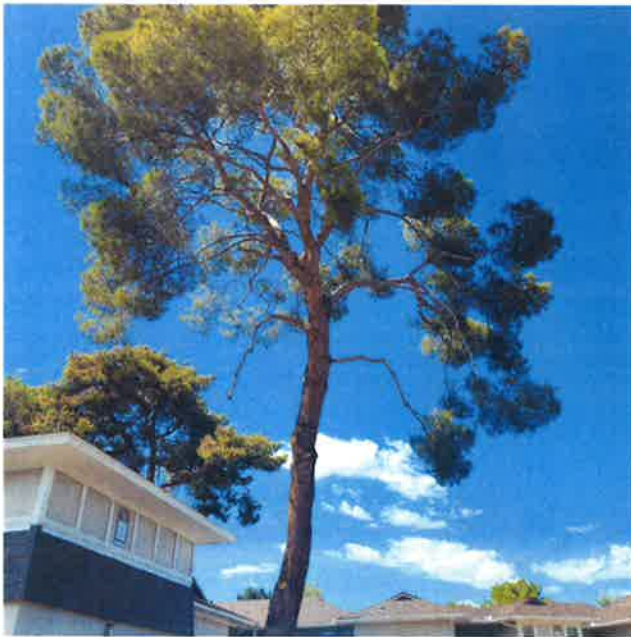
Bldg 9/Tree #5: Pine, add emitters (12 per tree as per SNWA recommendations); prune dead branches

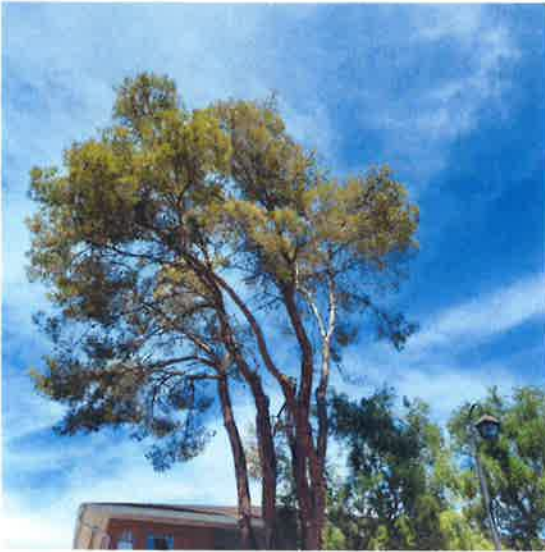
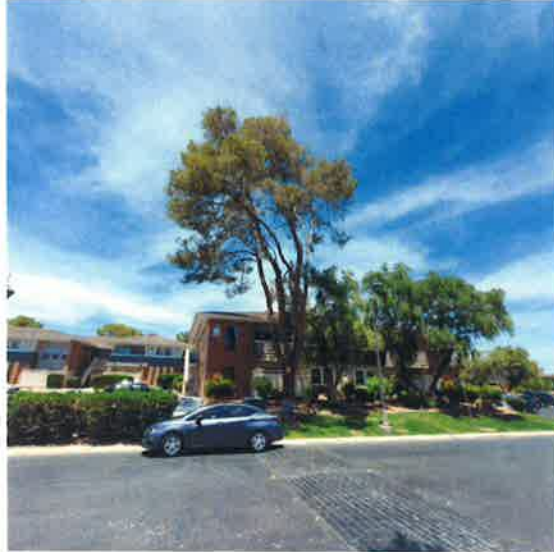
Bldg 15/ Tree #6: Pine, add emitters on planter/rock side of tree (one/half of root base - other half is covered with turf spray water; 6 per tree as per SNWA recommendations); prune dead branches

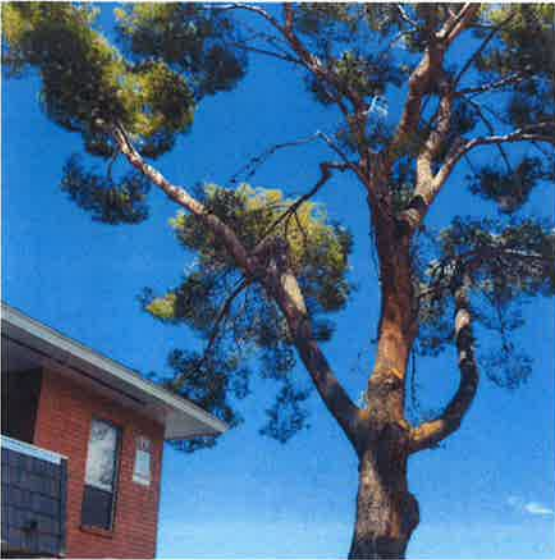
Bldg 19/Tree #7: Prune dead branches; add emitters (12 per tree as per SNWA recommendations);

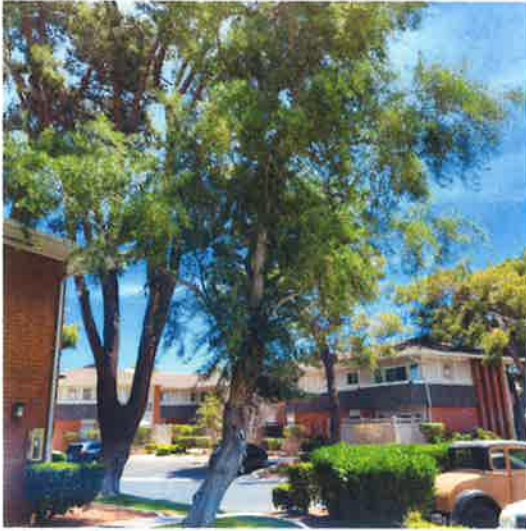
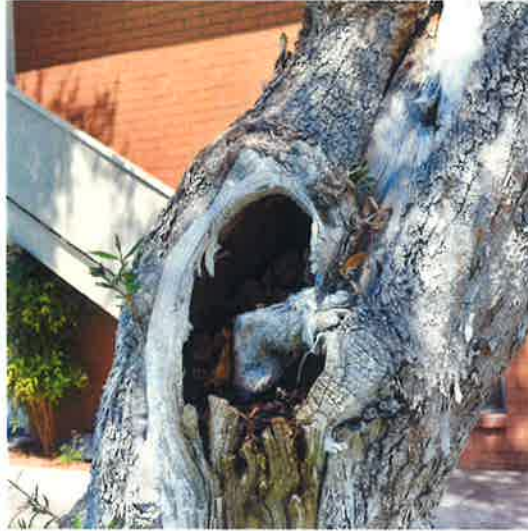
Bldg 19/Tree #8: Olive Tree, no change in cavity size; tree continues to show improvement; no maintenance required at this point; continue to monitor

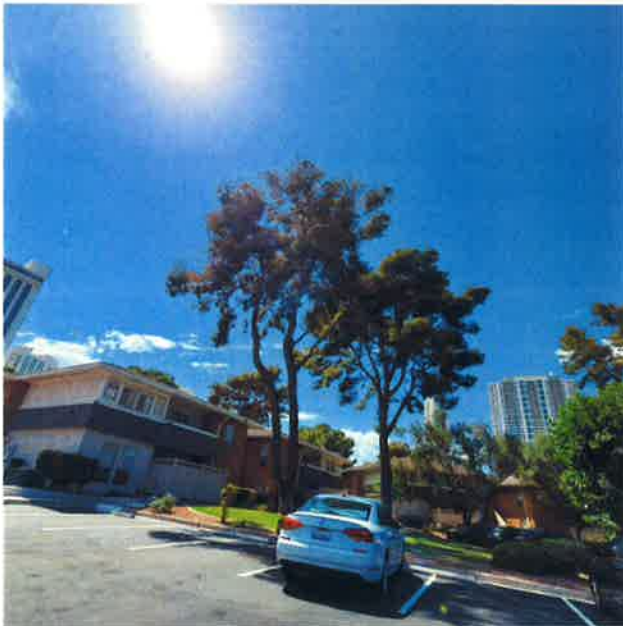
Bldg 27/Tree #9: Aleppo Pine continues to show signs of stress; remove dead branches; continue to monitor and possible remove and replace in 2-3 year;

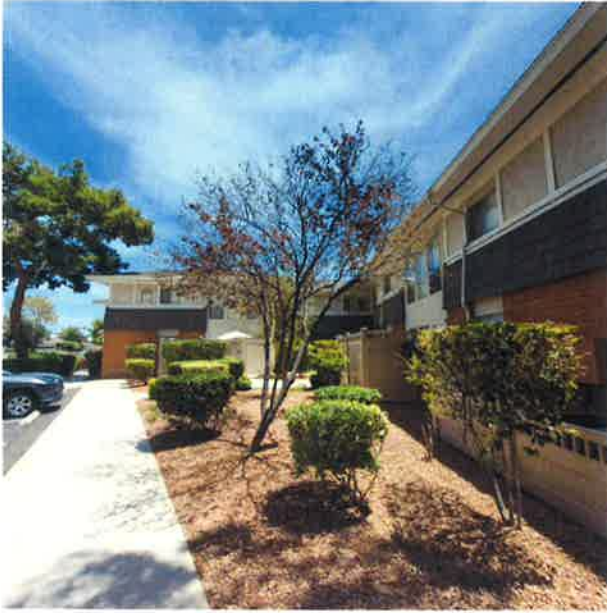
Bldg 39/Tree #10: Purple Leaf Plum; remove and replace with Oak or Vitex (Chaste Tree)

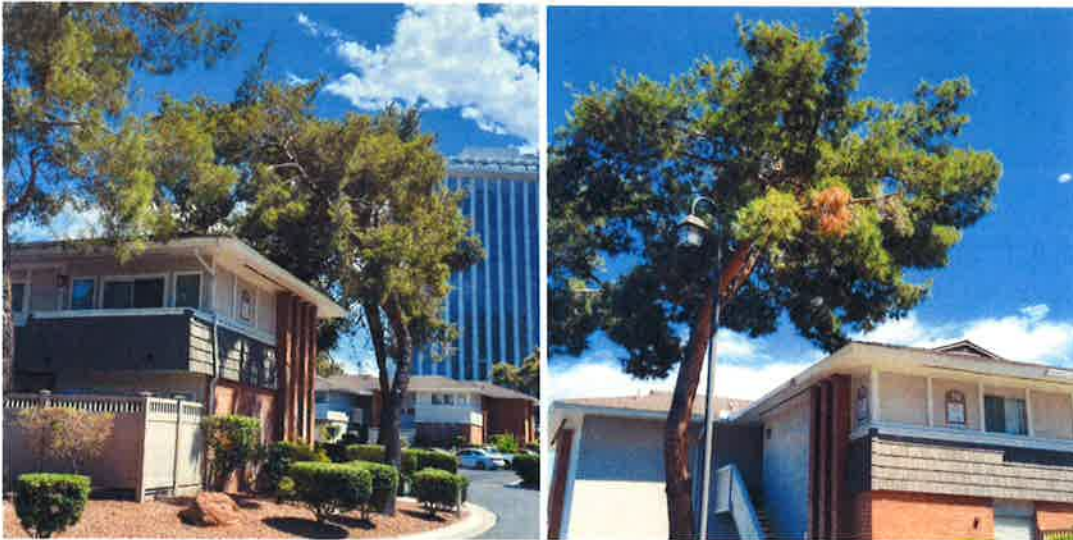
Bldg 39/Tree #11 & 12: Aleppo Pine; no change in lean; remove dead branches and any branches touching roof; Aleppo Pine, prune dead branches, add emitters (12 per tree as per SNWA recommendations); continue to monitor;

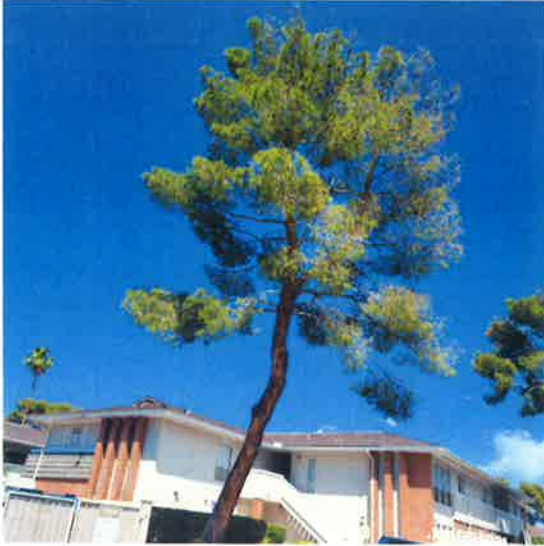
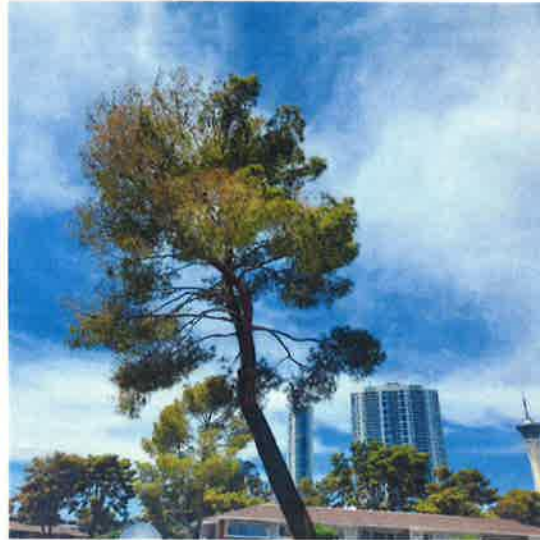
Bldg 40/Tree #12: Aleppo Pine continues to stress; very important to add emitters (12 per tree as per SNWA recommendations); continue to monitor; no change in lean

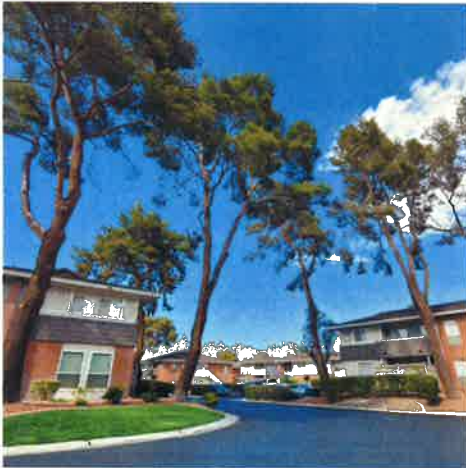
Bldg 38/Tree #14 & 15: Two Aleppo Pine on south side along Geary Place; continue to stress: prune dead branches; add emitters (12 per tree as per SNWA recommendations); continue to monitor;

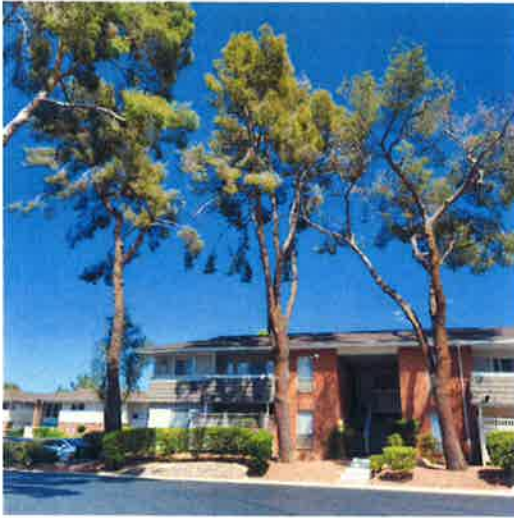
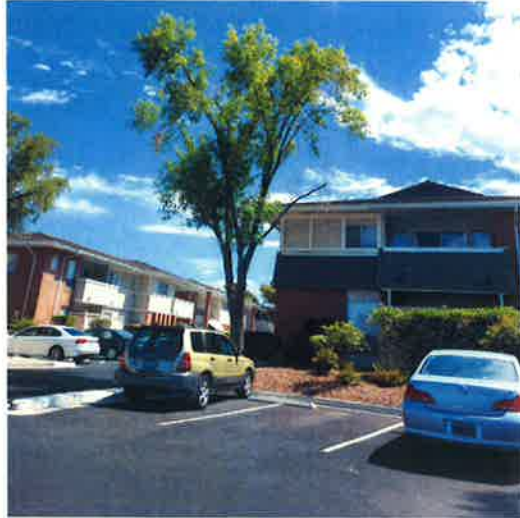
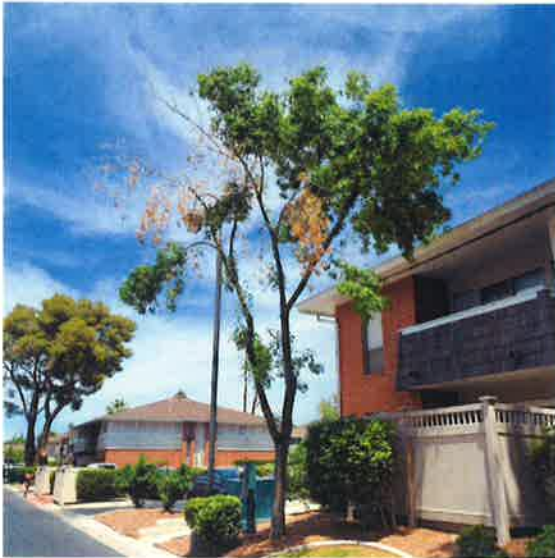
Bldg 22/Trees #16, 17, 18, 19, 20: Three Aleppo Pine (noted as N-05, 06, 07 in 2020 report) continue to stress: prune dead branches; add emitters (12 per tree as per SNWA recommendations); continue to monitor; One Ash north side, remove dead branches; add emitters (12 per tree as per SNWA recommendations); One Ash west side, remove dead branches; add emitters (12 per tree as per SNWA recommendations);

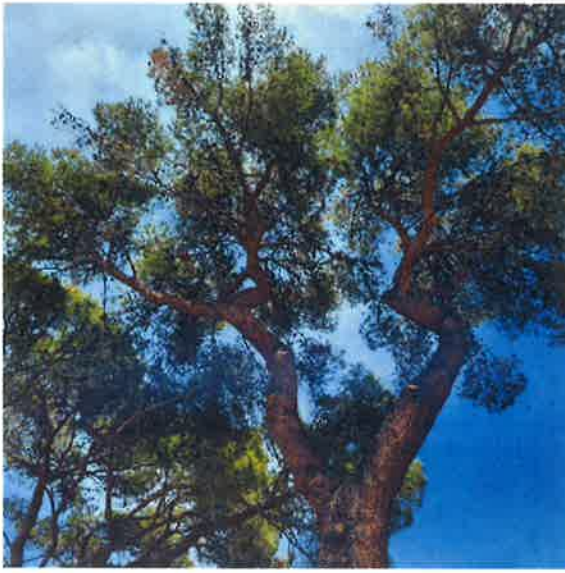
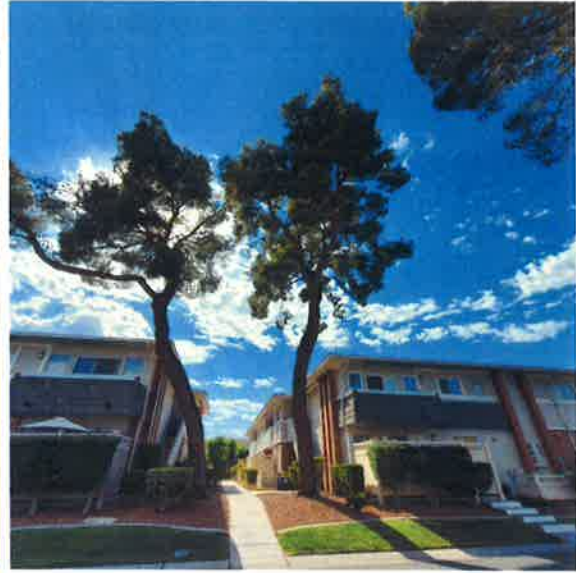
Bldg 38 Tree #21: Aleppo Pine: prune dead branches; tree health and structure is improving; no change in lean; Bldg 36/Tree #22, prune dead branches; add emitters to both trees (12 per tree as per SNWA recommendations);

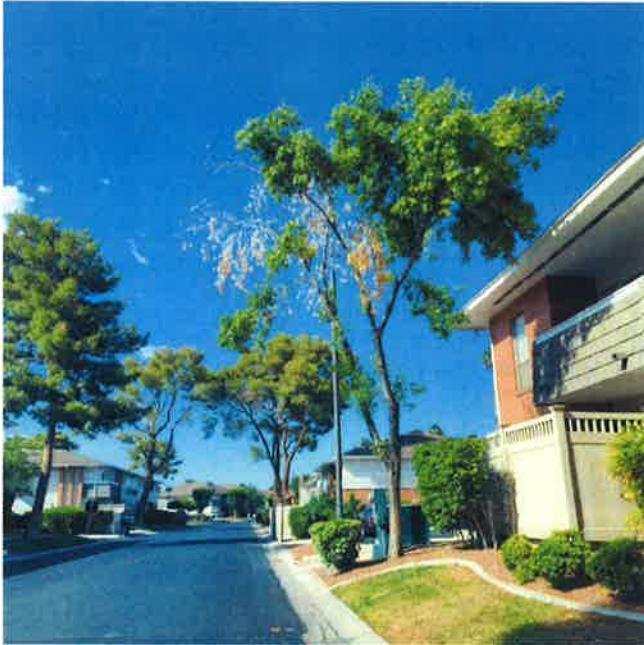
Bldg 18/Tree #23: Ash, prune dead limbs; add emitters (12 per tree as per SNWA recommendations);

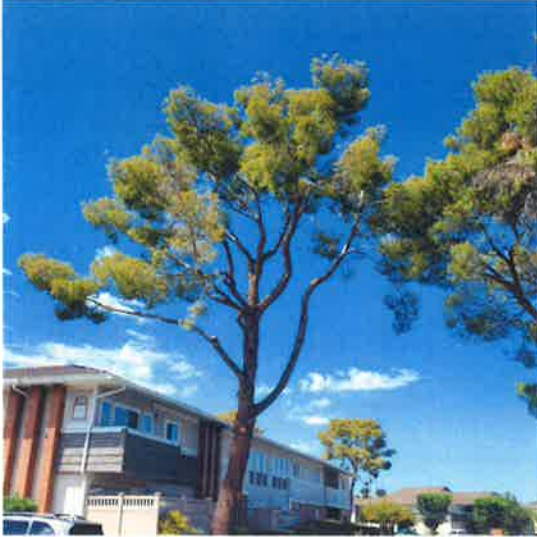
Bldg 34/Tree #24: Aleppo Pine; prune dead limbs; add emitters (12 per tree as per SNWA recommendations);

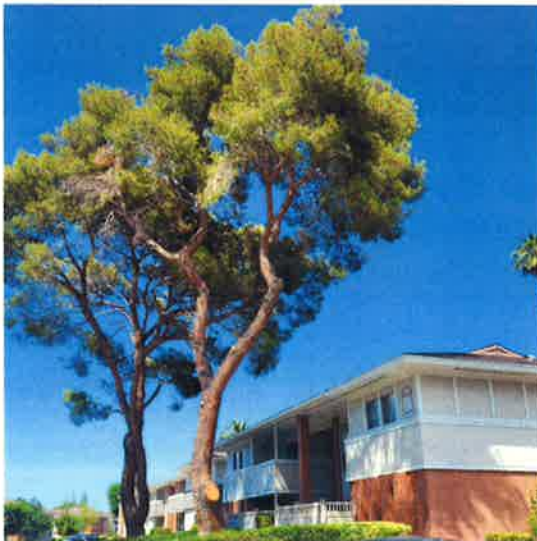
Bldg 14/Tree #25: Aleppo Pine; prune dead limbs; add emitters (12 per tree as per SNWA recommendations);
