July 22, 2020 (revised)

Please see the below recommendations as a followup to the June 25, 2019 Sunkissed Horticultural Consultant's tree assessment and a list of additional trees for removal or monitoring,

MONTEREY 2020 TREE REPORT PHOTOS

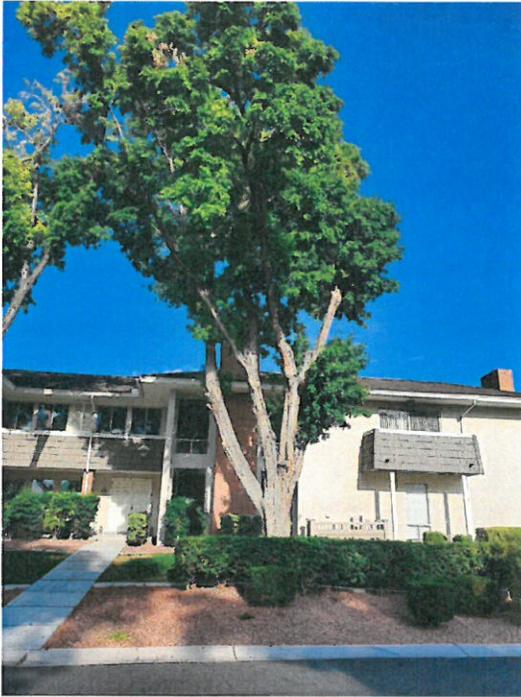
Tree #1 Arizona Ash: tree health and structure is improving; continue to monitor

#1 (AZ) Continue to monitor

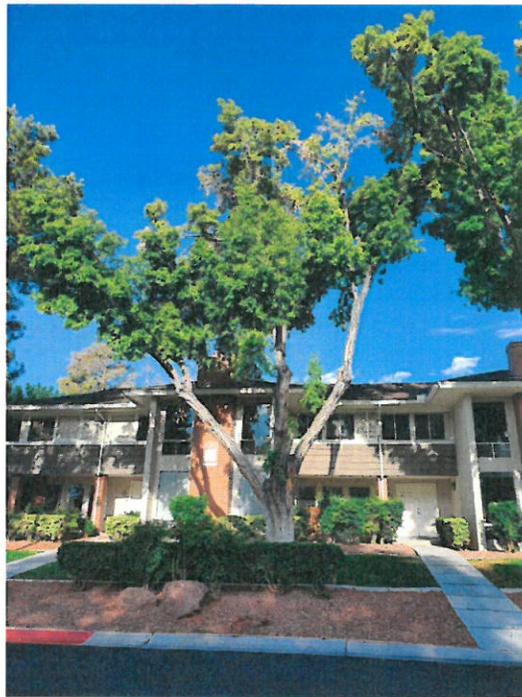
Tree #2 Arizona Ash: tree health and structure is improving; continue to monitor

#2 (AZ) Continue to monitor

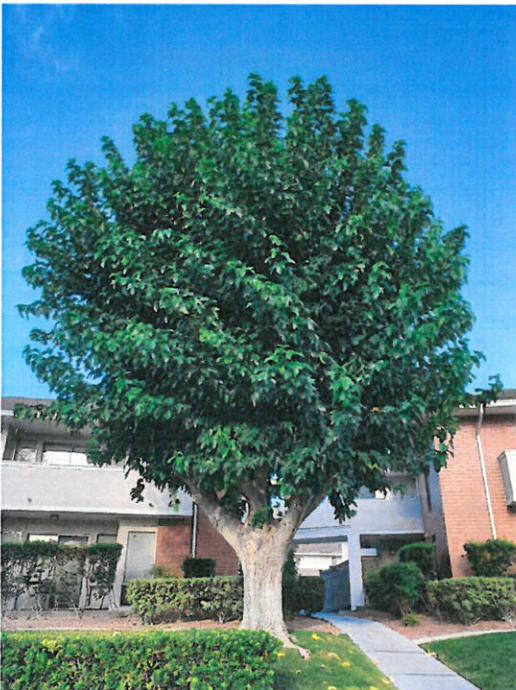
Tree #4 Mulberry: tree health and structure is improving; continue to monitor

#4 (FM) Fully recovered; remove from monitor list

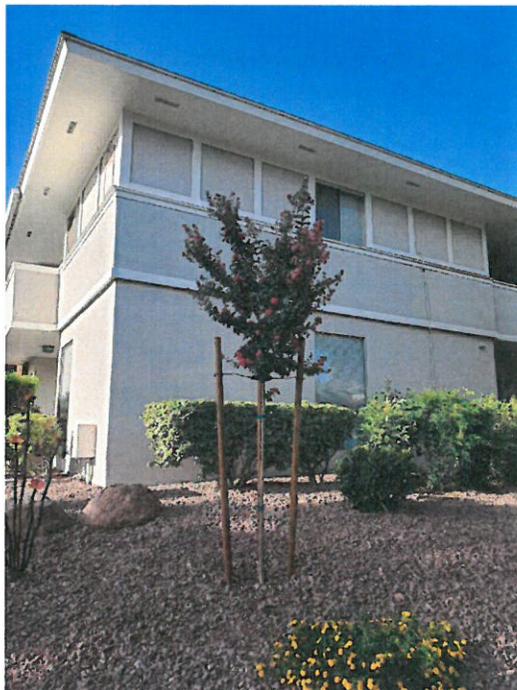
Tree #5 Arizona Ash: removed; replaced with crape myrtle

#5 (AZ) Removed and replaced with Crape Myrtle

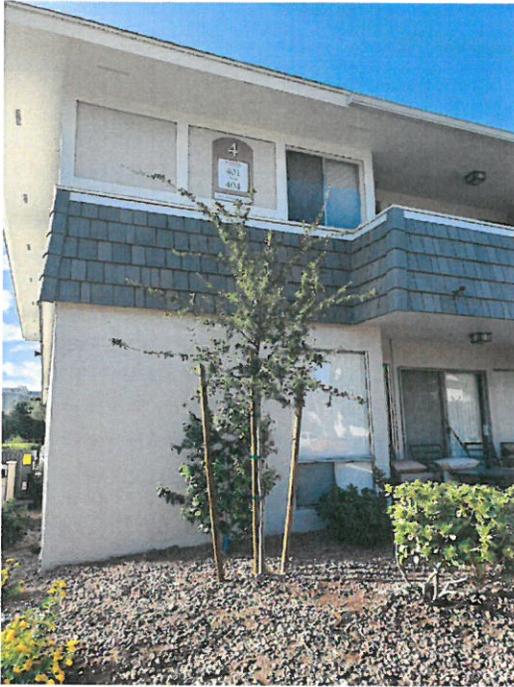
Tree #8 Aleppo Pine: removed; replaced with oak

#8 (AP) Removed and replaced w/Oak

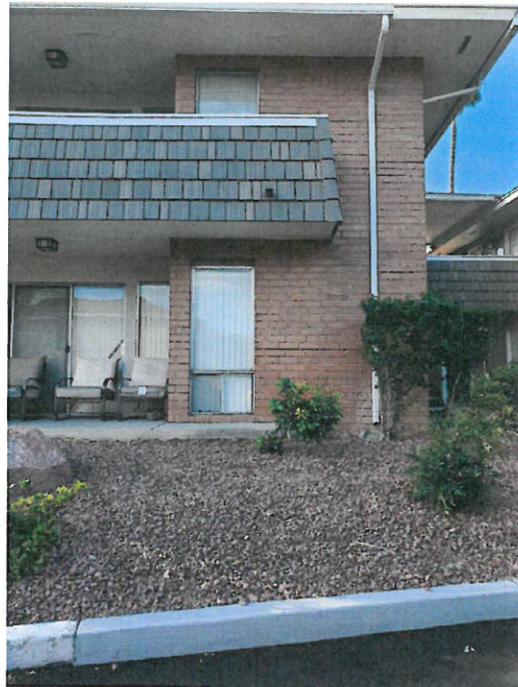
Tree #9 Aleppo Pine: removed not replaced

#9 (AP) Removed, not replaced

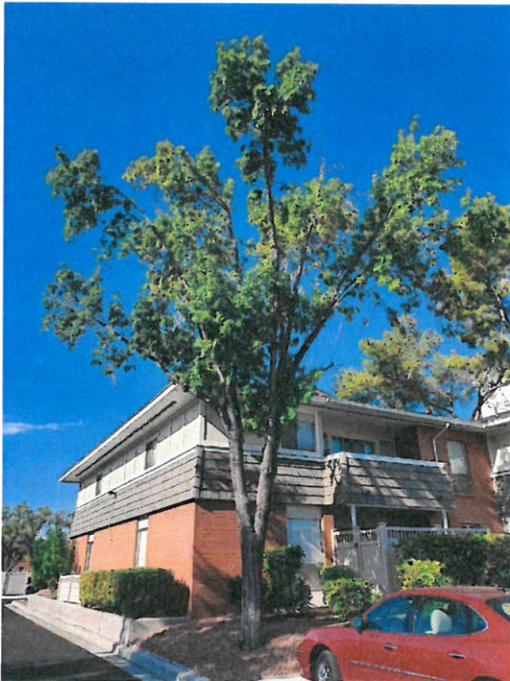
Tree #12 Arizona Ash: some improvement; continue to monitor; add emitters to increase water

#12 (AZ) Continue to monitor

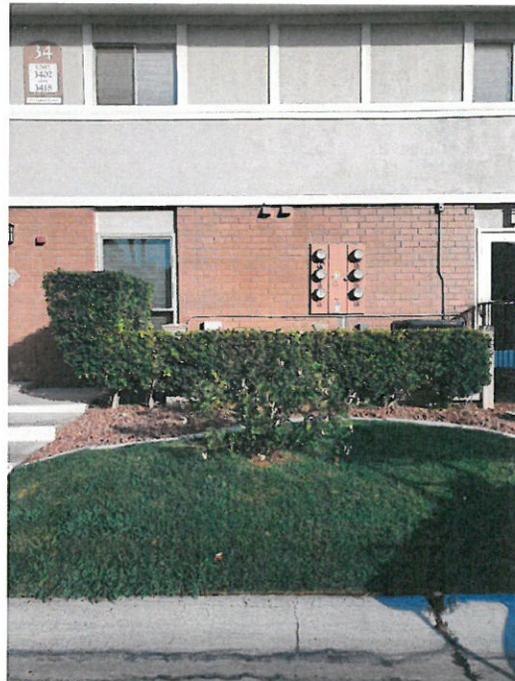
Tree #14 Arizona Ash: removed; replaced with Sophoro (Texas Mountain Laurel)

#14 (AZ) Removed, replaced with Sophora

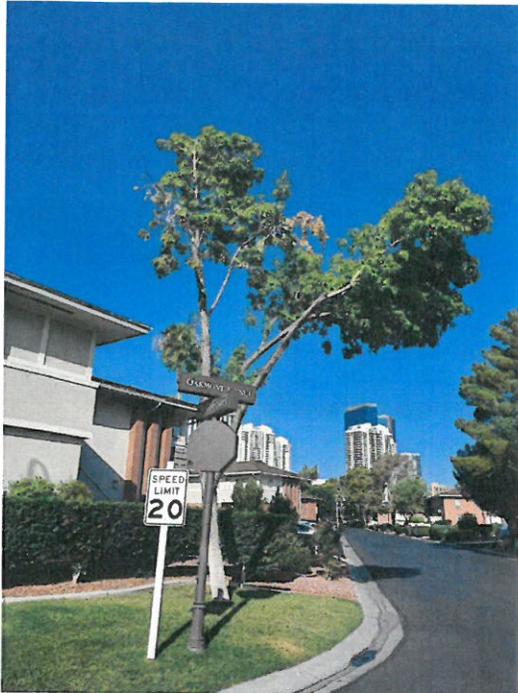
Tree #15 Arizona Ash: adjacent tree in this area was removed and not replaced; recommended to remove #15 and replace

#15 (AZ) Removed; recommended to remove and replace remaining stressed AZ in this area

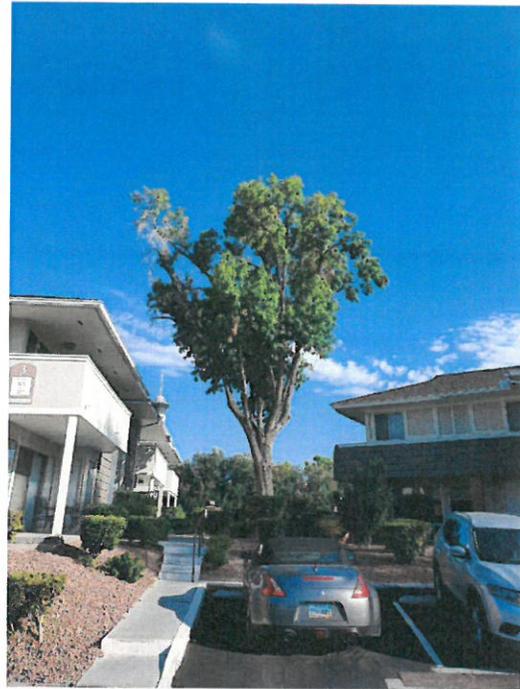
Tree #17 Arizona Ash: tree health and structure is improving; continue to monitor

#17 (AZ) Continue to monitor

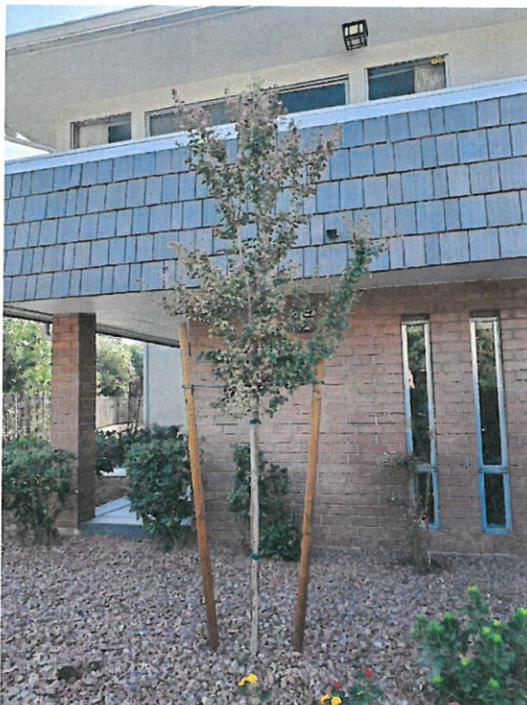
Tree #18 Aleppo Pine: removed and replaced with crape myrtle

#18 (AP) Removed and replaced with Crape Myrtle

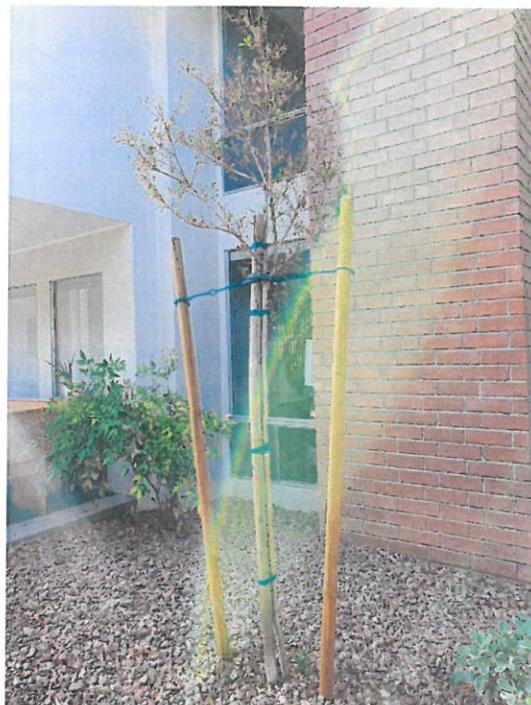
Tree #19 Arizona Ash: removed and replaced with crape myrtle

#19 (AZ) Removed and replaced with Crape Myrtle

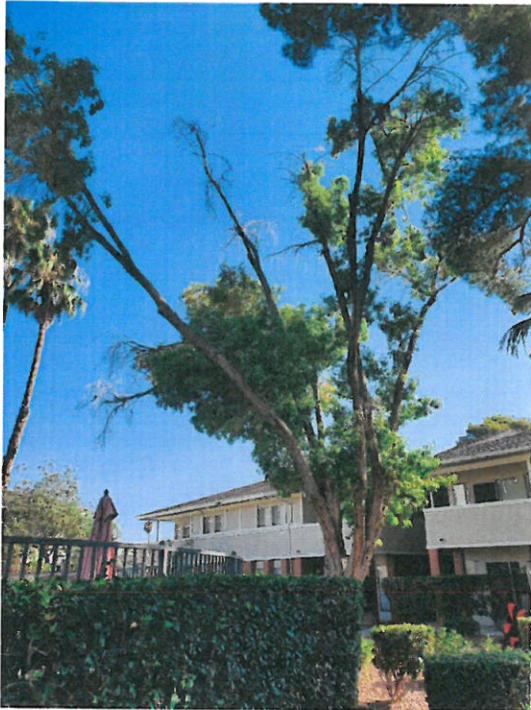
Tree #21 Arizona Ash: tree put on some insignificant new growth, recommended to remove and replace

#21 (AZ) Recommended to remove and replace

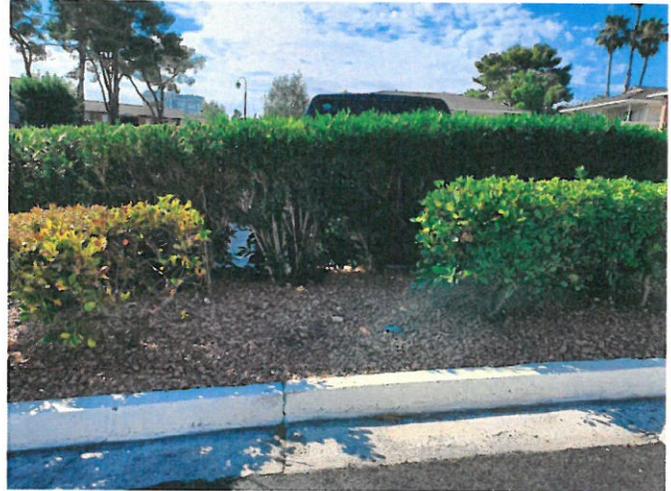
Tree #22 Mimosa: removed and not replaced

#22 (MM) Removed and not replaced

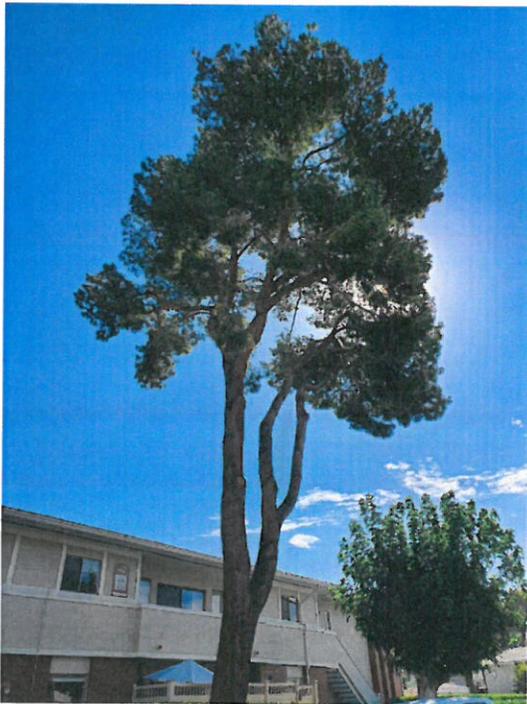
Tree #39 Aleppo Pine: tree health and structure is improving; continue to monitor

#39 (AP) Improving; continue to monitor

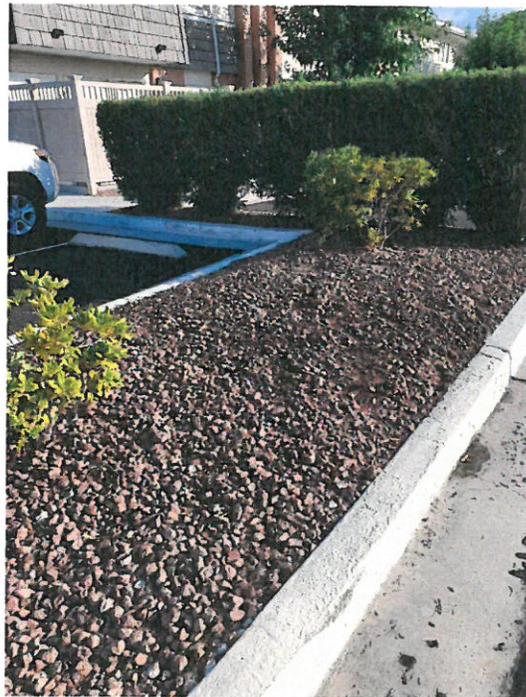
Tree #40 Mulberry: removed not replaced

#40 (FM) Removed not replaced

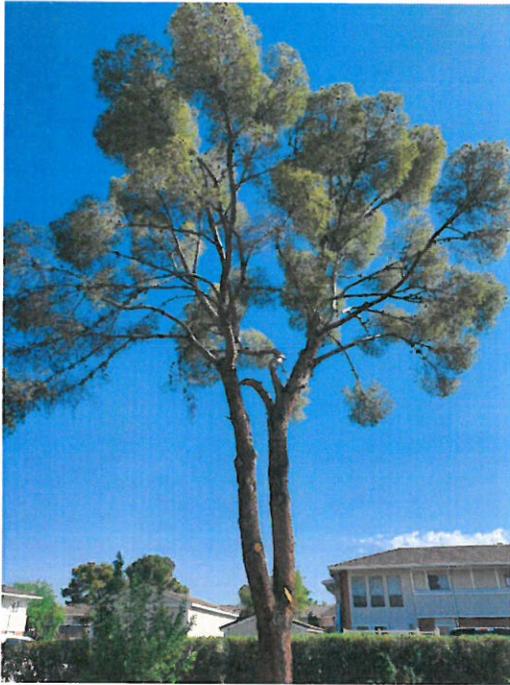
Tree #42 Aleppo Pine: no improvement, continue to monitor and consider for possible removal

#42 (AP) No improvement; continue to monitor and consider for possible removal

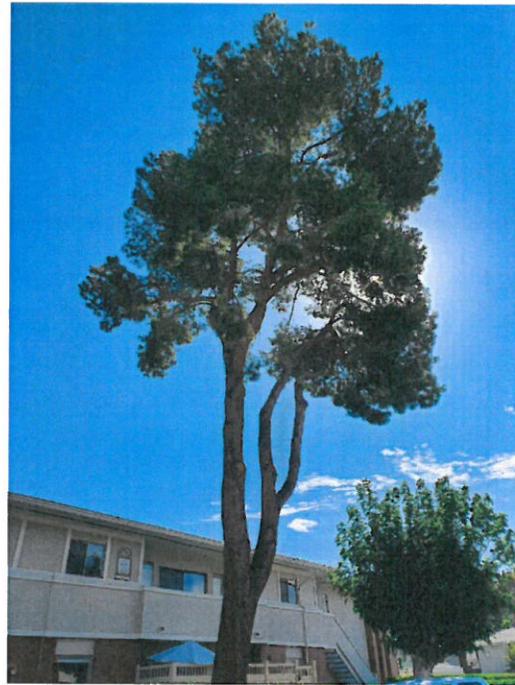
Tree #44 Aleppo Pine: tree health and structure is improving; continue to monitor

#44 (AP) Improving; continue to monitor

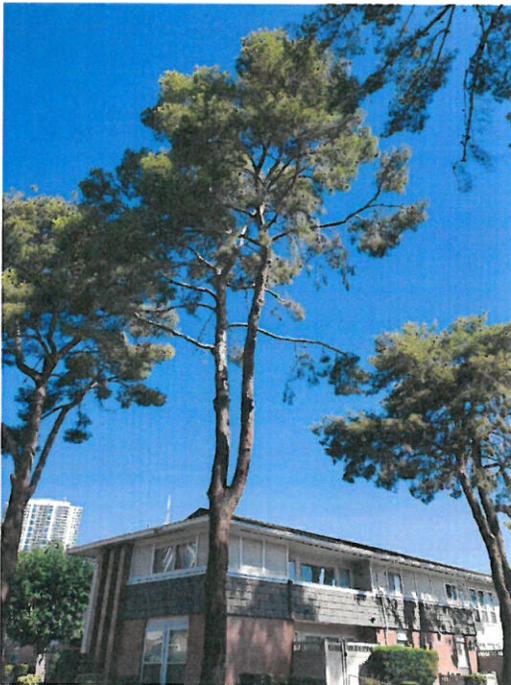
Tree #46 Aleppo Pine: tree health and structure is improving; continue to monitor

#46 (AP) Improving, continue to monitor

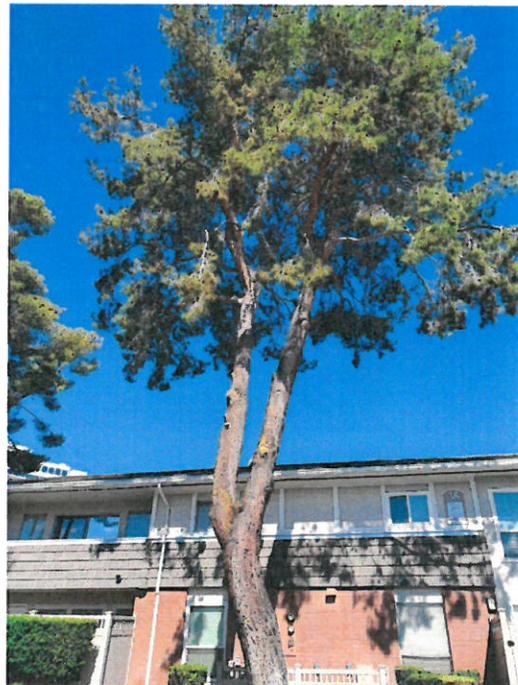
Tree #47 Aleppo Pine: tree health and structure is improving; continue to monitor

#47 (AP) Improving, continue to monitor

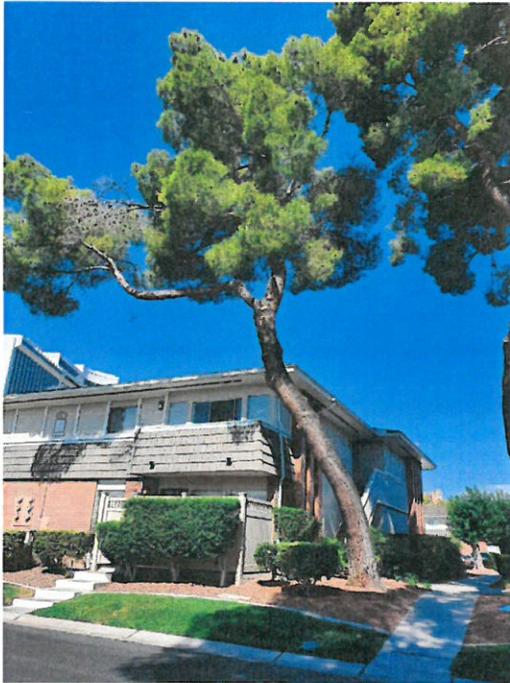
Tree #48 Aleppo Pine: tree health and structure is improving; no change in lean; needs a few dead limbs removed

#48 (AP) No change in lean; continue to monitor; remove dead limbs

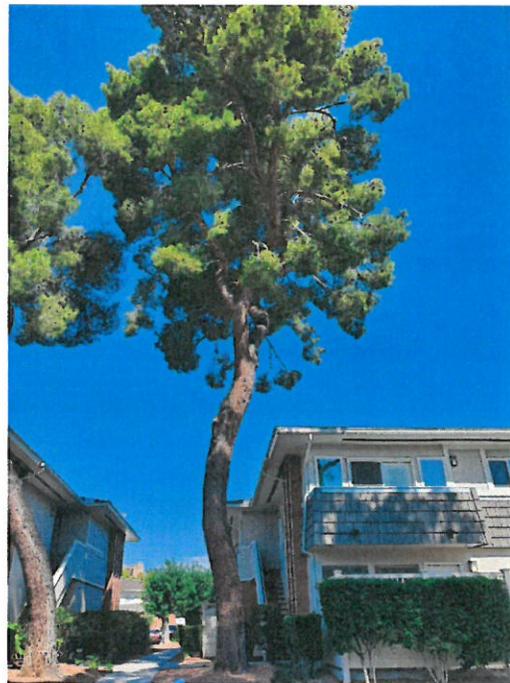
Tree #49 Aleppo Pine: tree health and structure is improving; continue to monitor

#49 (AP) Improving; continue to monitor

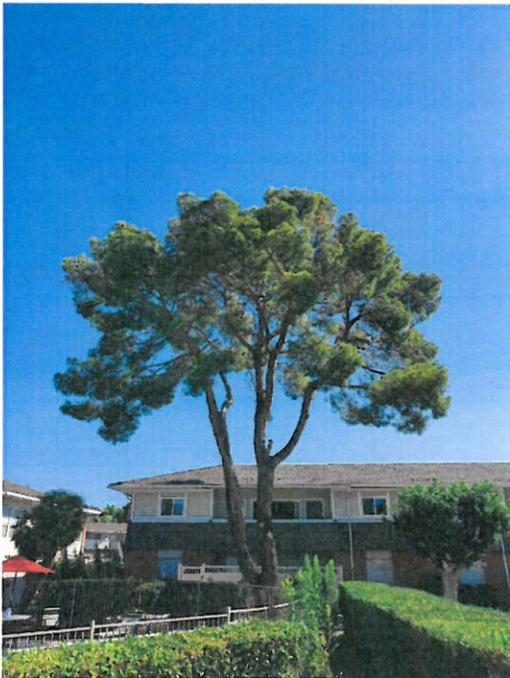
Tree #52 Aleppo Pine: tree health and structure is improving; remove one dead limb and continue to monitor

#52 (AP) Improving, continue to monitor

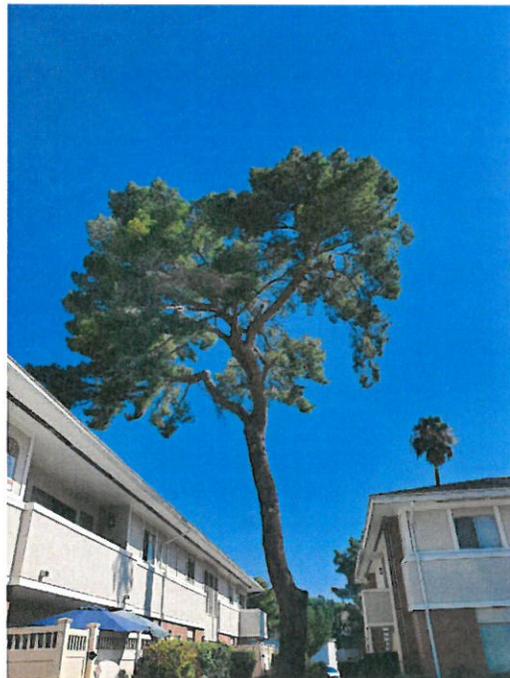
#55 (AP) Improving; remove one dead limb; continue to monitor

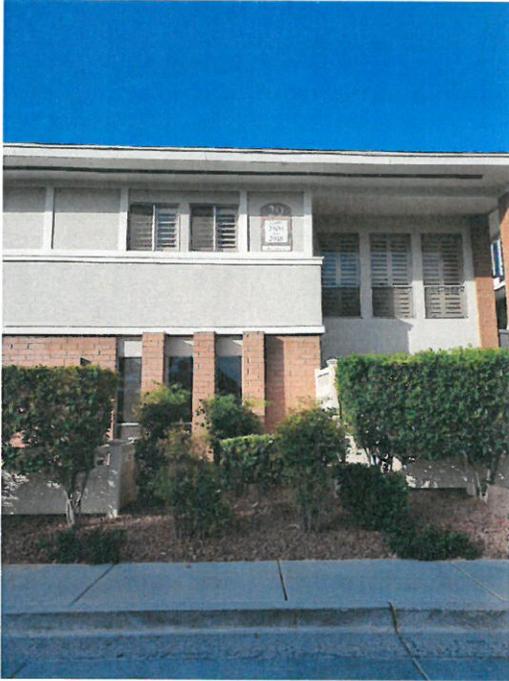
58 (AP) Removed not replaced

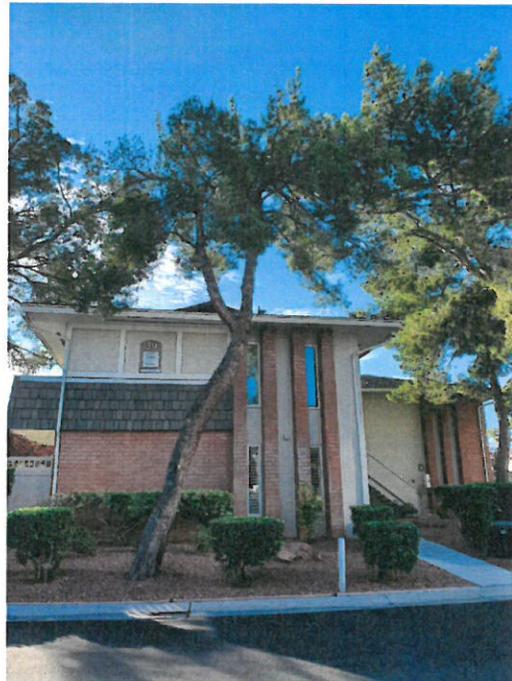
#63 (AP) Improving; no change in lean;
continue to monitor

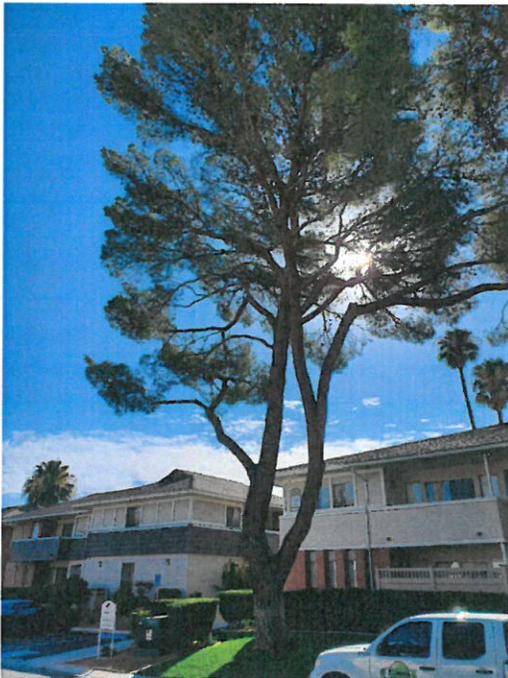
#67 (AP) Improving, continue to monitor

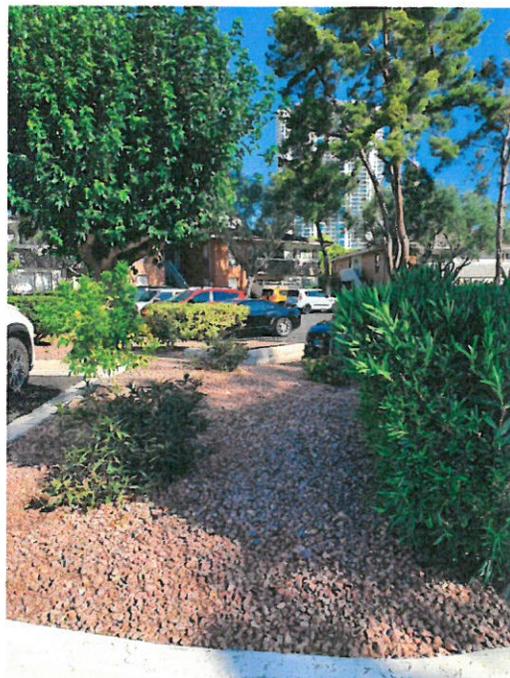
#70 (AP) Removed not replaced

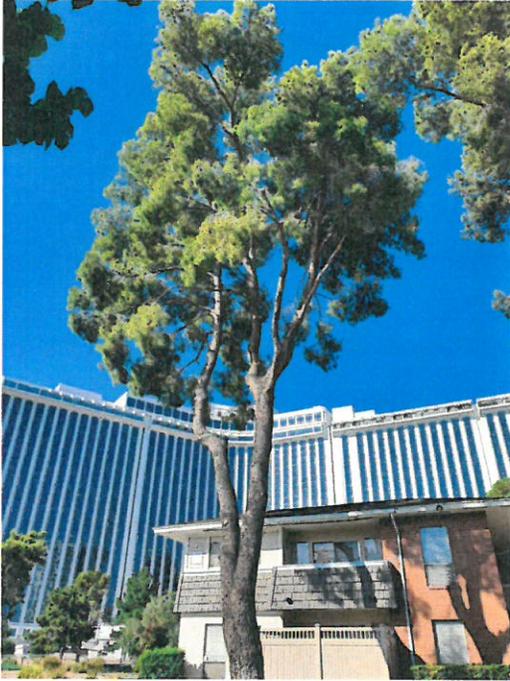
#71 (AP) Improving; continue to monitor

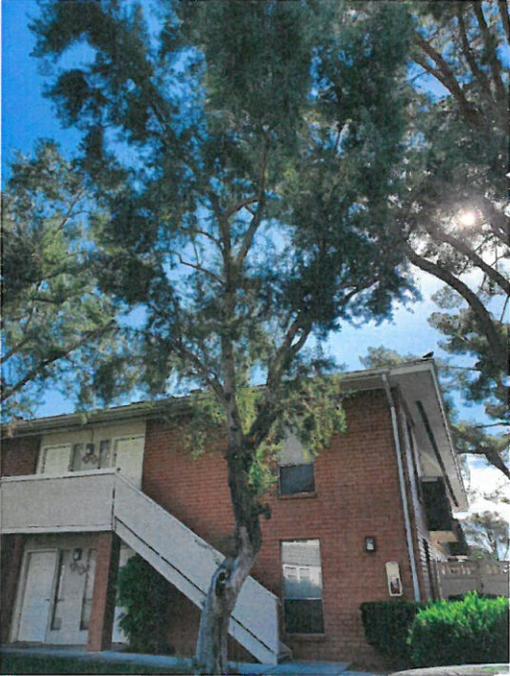
#72 (EO) Improving; continue to monitor

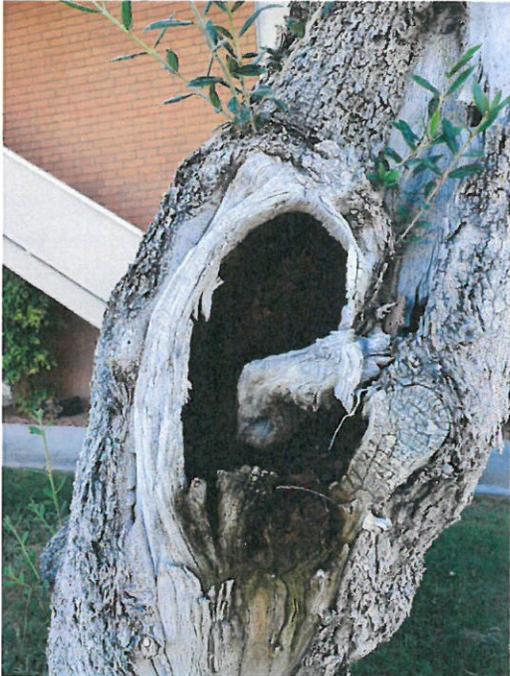
#72 (EO) Decay; continue to monitor

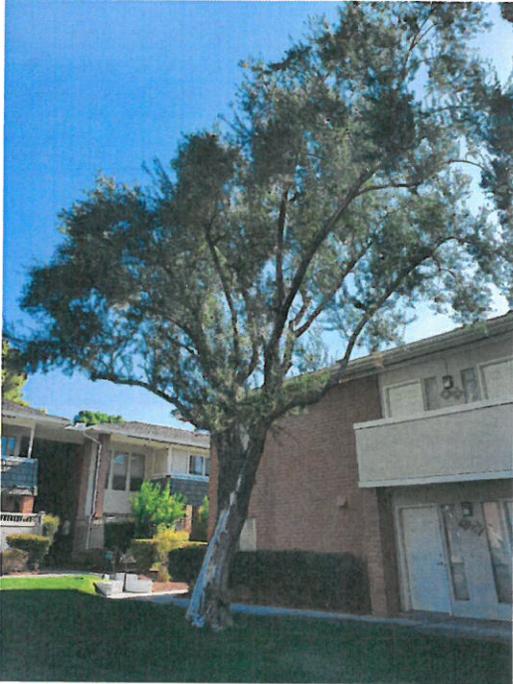
#73 (EO) Improving; continue to monitor

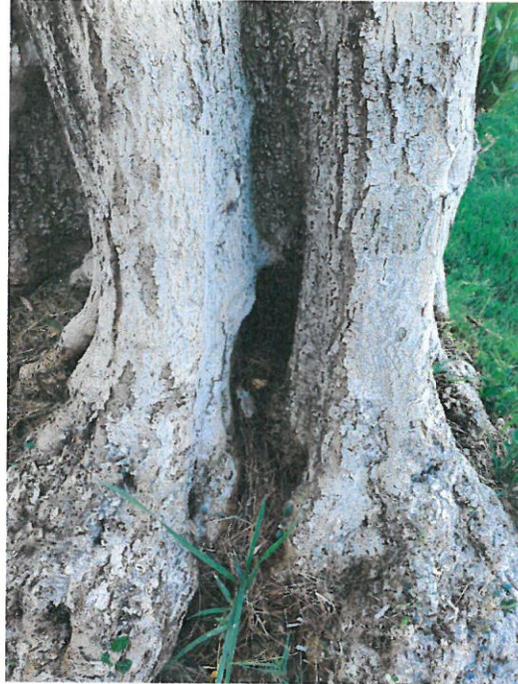
#73 (EO) Decay; continue to monitor

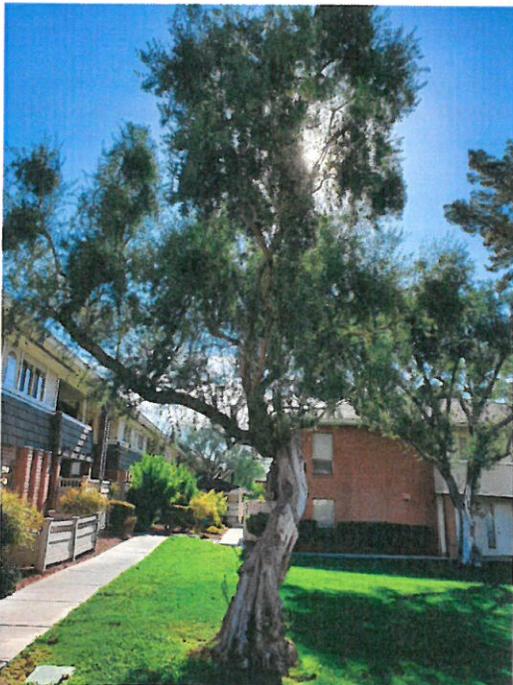
#74 (EO) Improving; continue to monitor

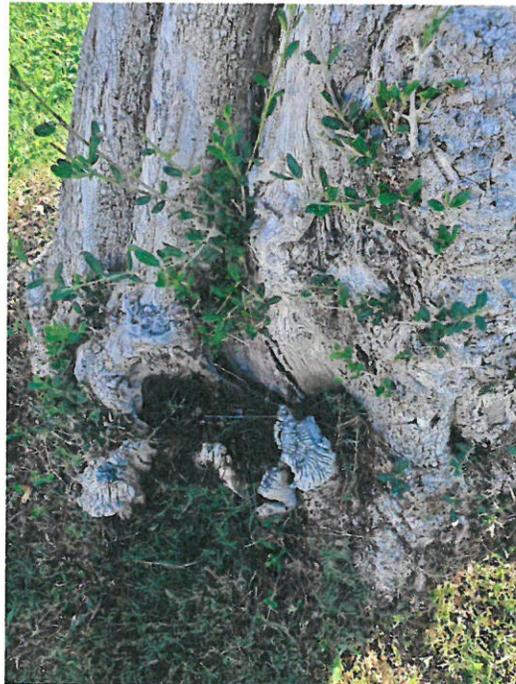
#74 (EO) Decay; continue to monitor

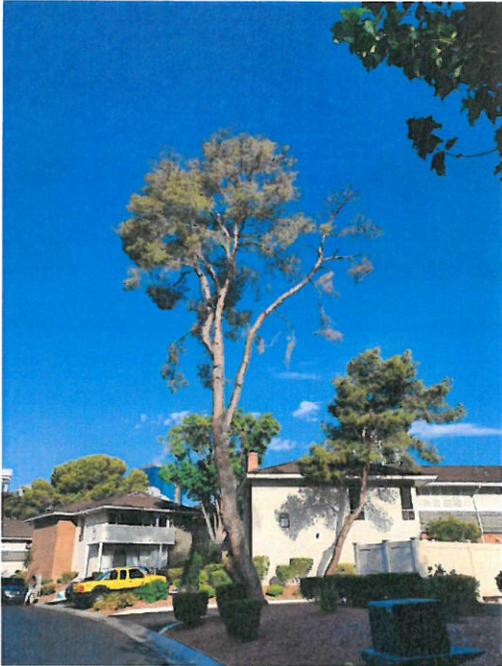
Tree #20 Aleppo Pine: Stressed/dying, had shown some improvement and was removed from consultant's Monitor List; now in severe decline and is recommended to remove and replace
Tree #N-01* (AZ): Stressed/dying; in close proximity to street light; remove and no replacement
Tree #N-02 (FM): Stressed/dying; remove and no replacement
Tree #N-03 (AP): Stressed, poor structure; remove and no replacement due to utility box
Tree #N-04 (AZ): Stressed, poor location (not enough soil volume in this planter area); remove and no replacement
Tree #N-05 (AP): Very stressed; in need of additional irrigation (add 10-12 emitters); continue to monitor
Tree #N-06 (AP): Very stressed; in need of additional irrigation (add 10-12 emitters); continue to monitor
Tree #N-07 (AP): Very stressed; remove large dead limb; in need of additional irrigation (add 10-12 emitters); continue to monitor

#20 (AP) Stressed/dying, had shown some improvement and was removed from Monitor List; now in decline again and recommended to remove and replace

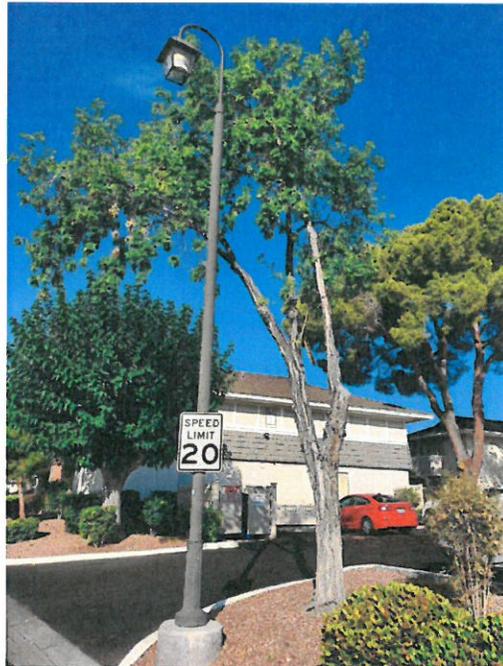
#N-01 (AZ) Stressed/dying; remove and no replace

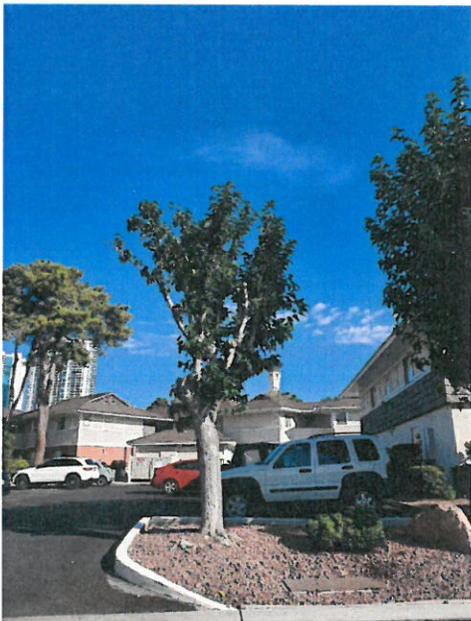
#N-02 (FM) Stressed/dying; remove and no replace

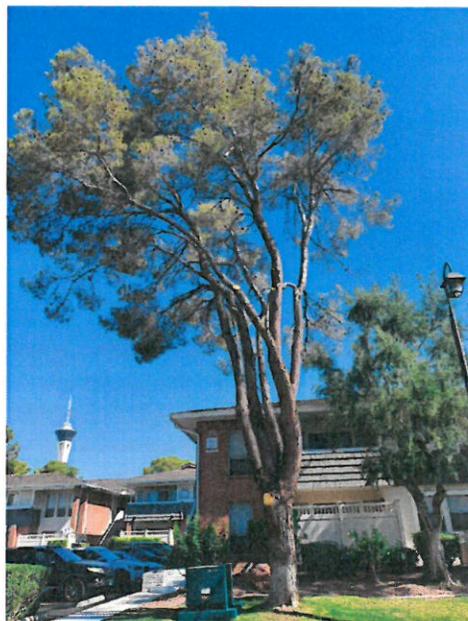
#N-03 (AP) Stressed, poor structure; remove and no replace due to utility box

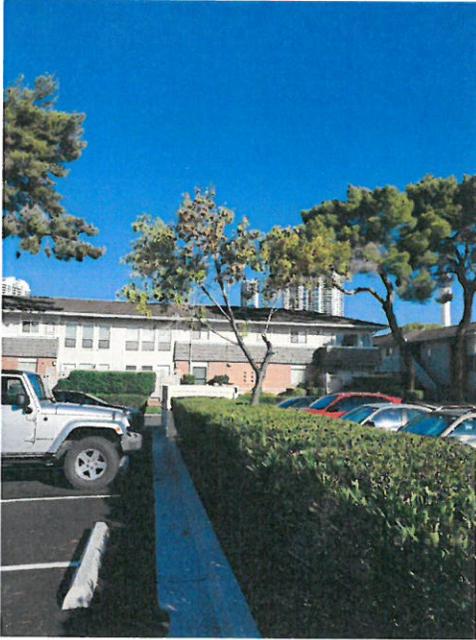
#N-04 (AZ) Stressed, poor location for a tree; remove and no replace

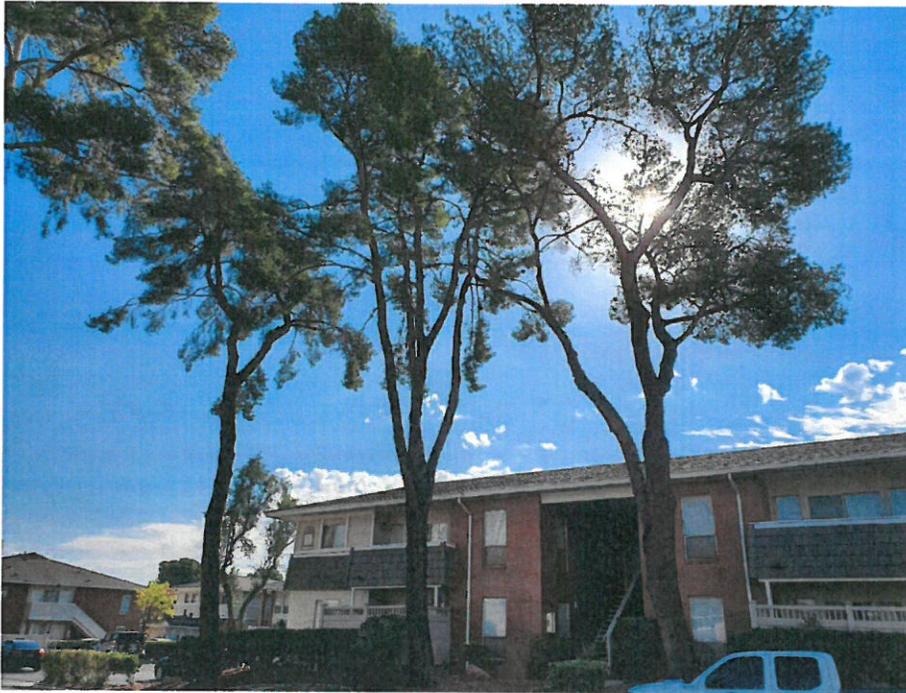
#N-05, 06, 07 (AP) Very stressed Pines west side of building #22. In need of additional irrigation (add 10-12 emitters per tree) as soon as possible. This is true of all AP onsite - could benefit from additional emitters.

In general, all Aleppo Pine are in need of additional irrigation, and many of the Ash as well. For any tree not located in a turf area, it is recommended to renovate the irrigation to add more emitters in larger concentric rings around the bases of the tree for better coverage of active root absorption area.
