July 22, 2020 (revised)

Please see the below recommendations as a followup to the June 25, 2019 Sunkissed Horticultural Consultant's tree assessment and a list of additional trees for removal or monitoring,

MONTEREY 2020 TREE REPORT PHOTOS

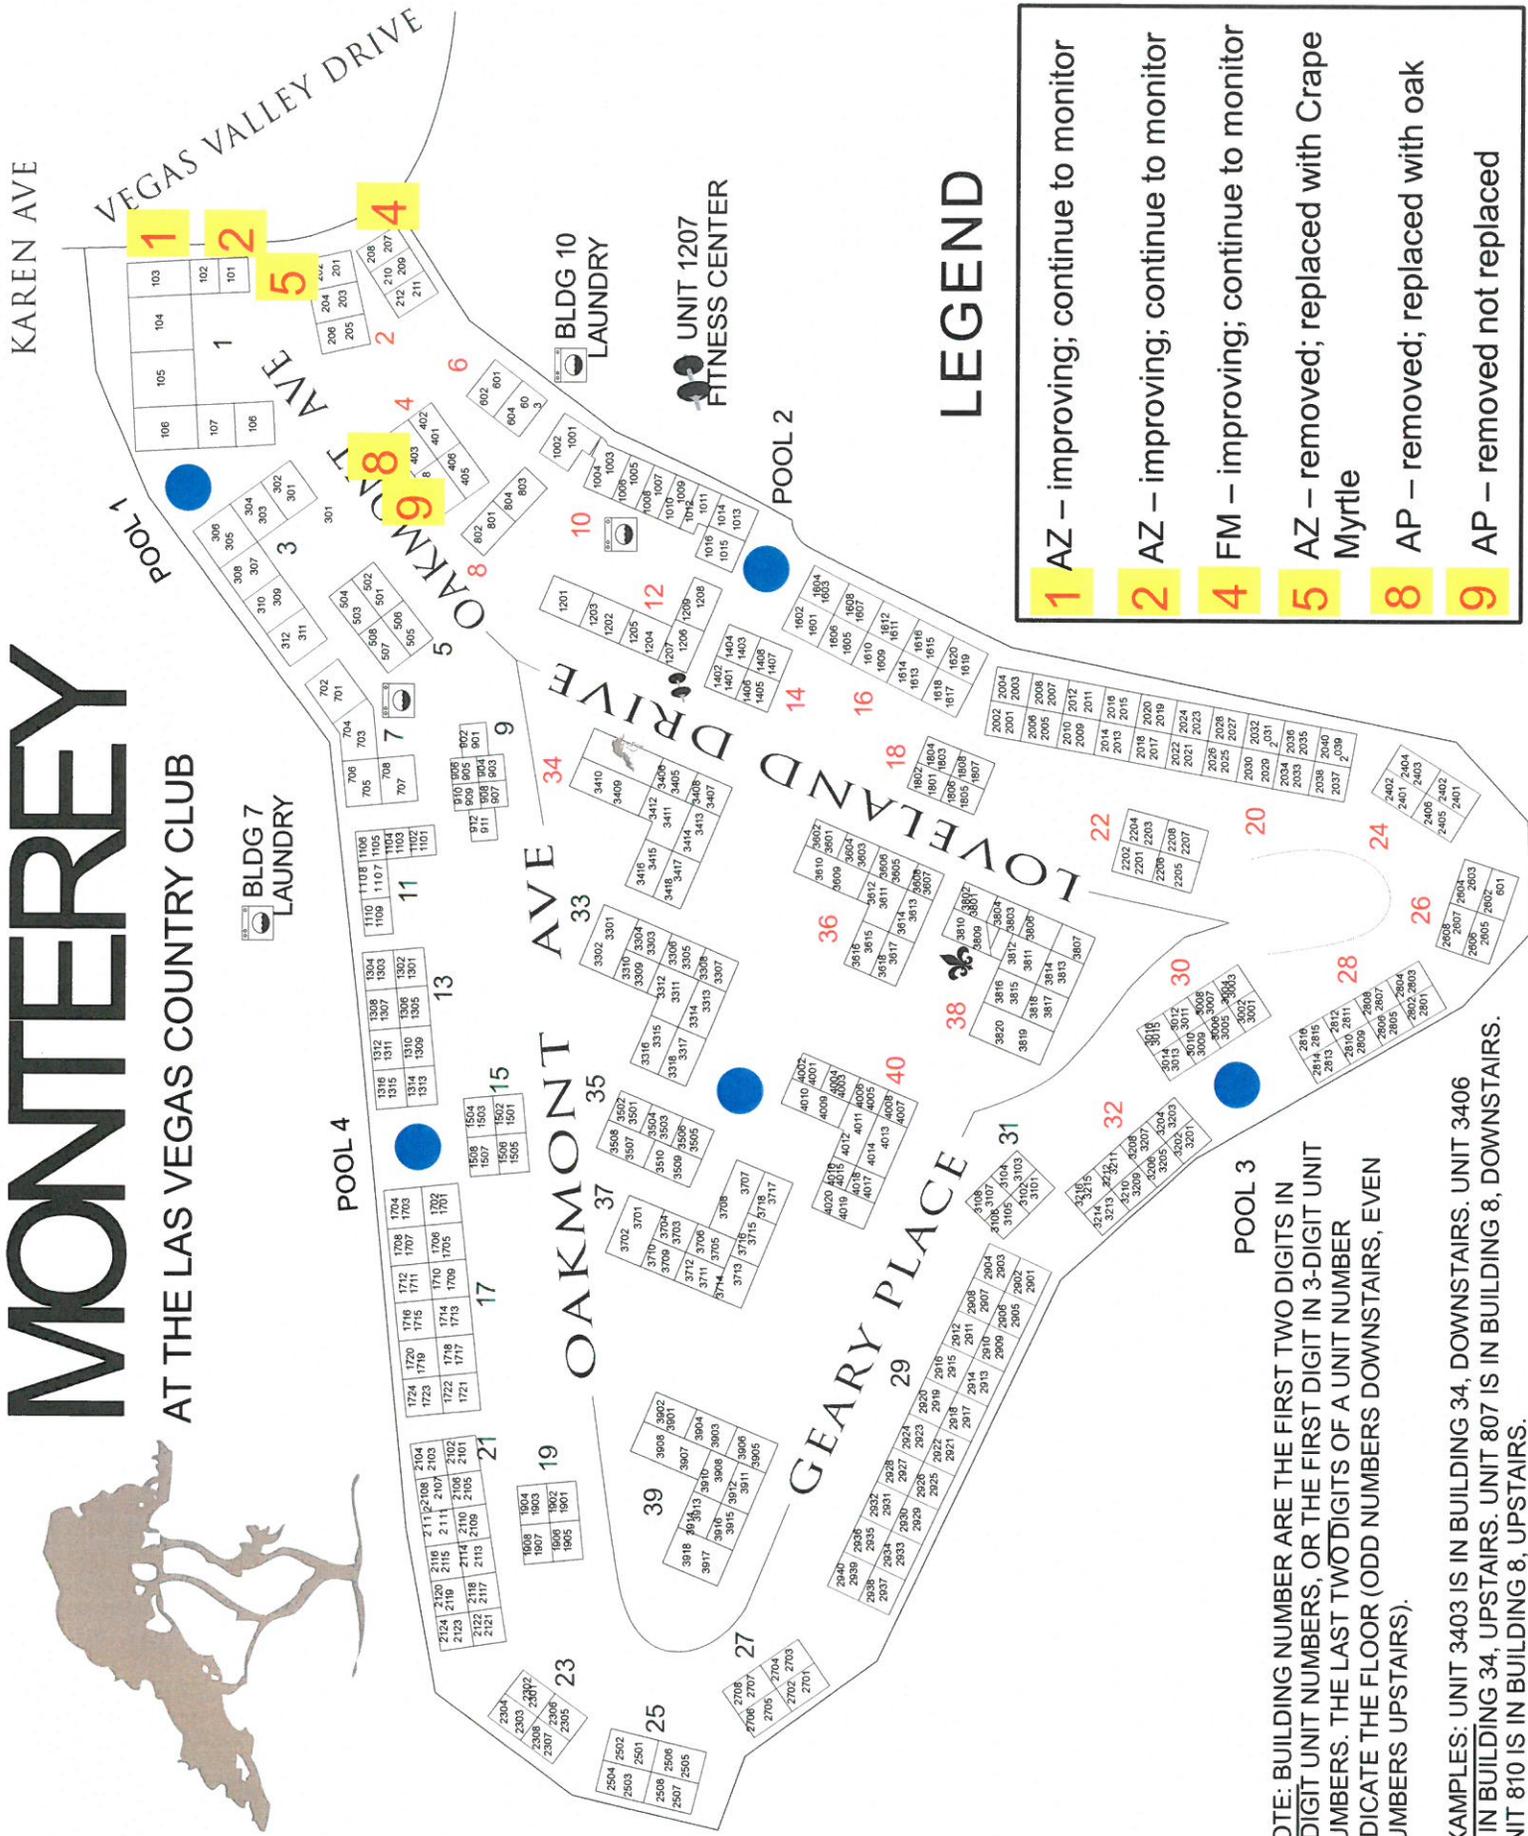
- 1** AZ – improving; continue to monitor
- 2** AZ – improving; continue to monitor
- 4** FM – improving; continue to monitor
- 5** AZ – removed; replaced with Grape Myrtle
- 8** AP – removed; replaced with oak
- 9** AP – removed not replaced

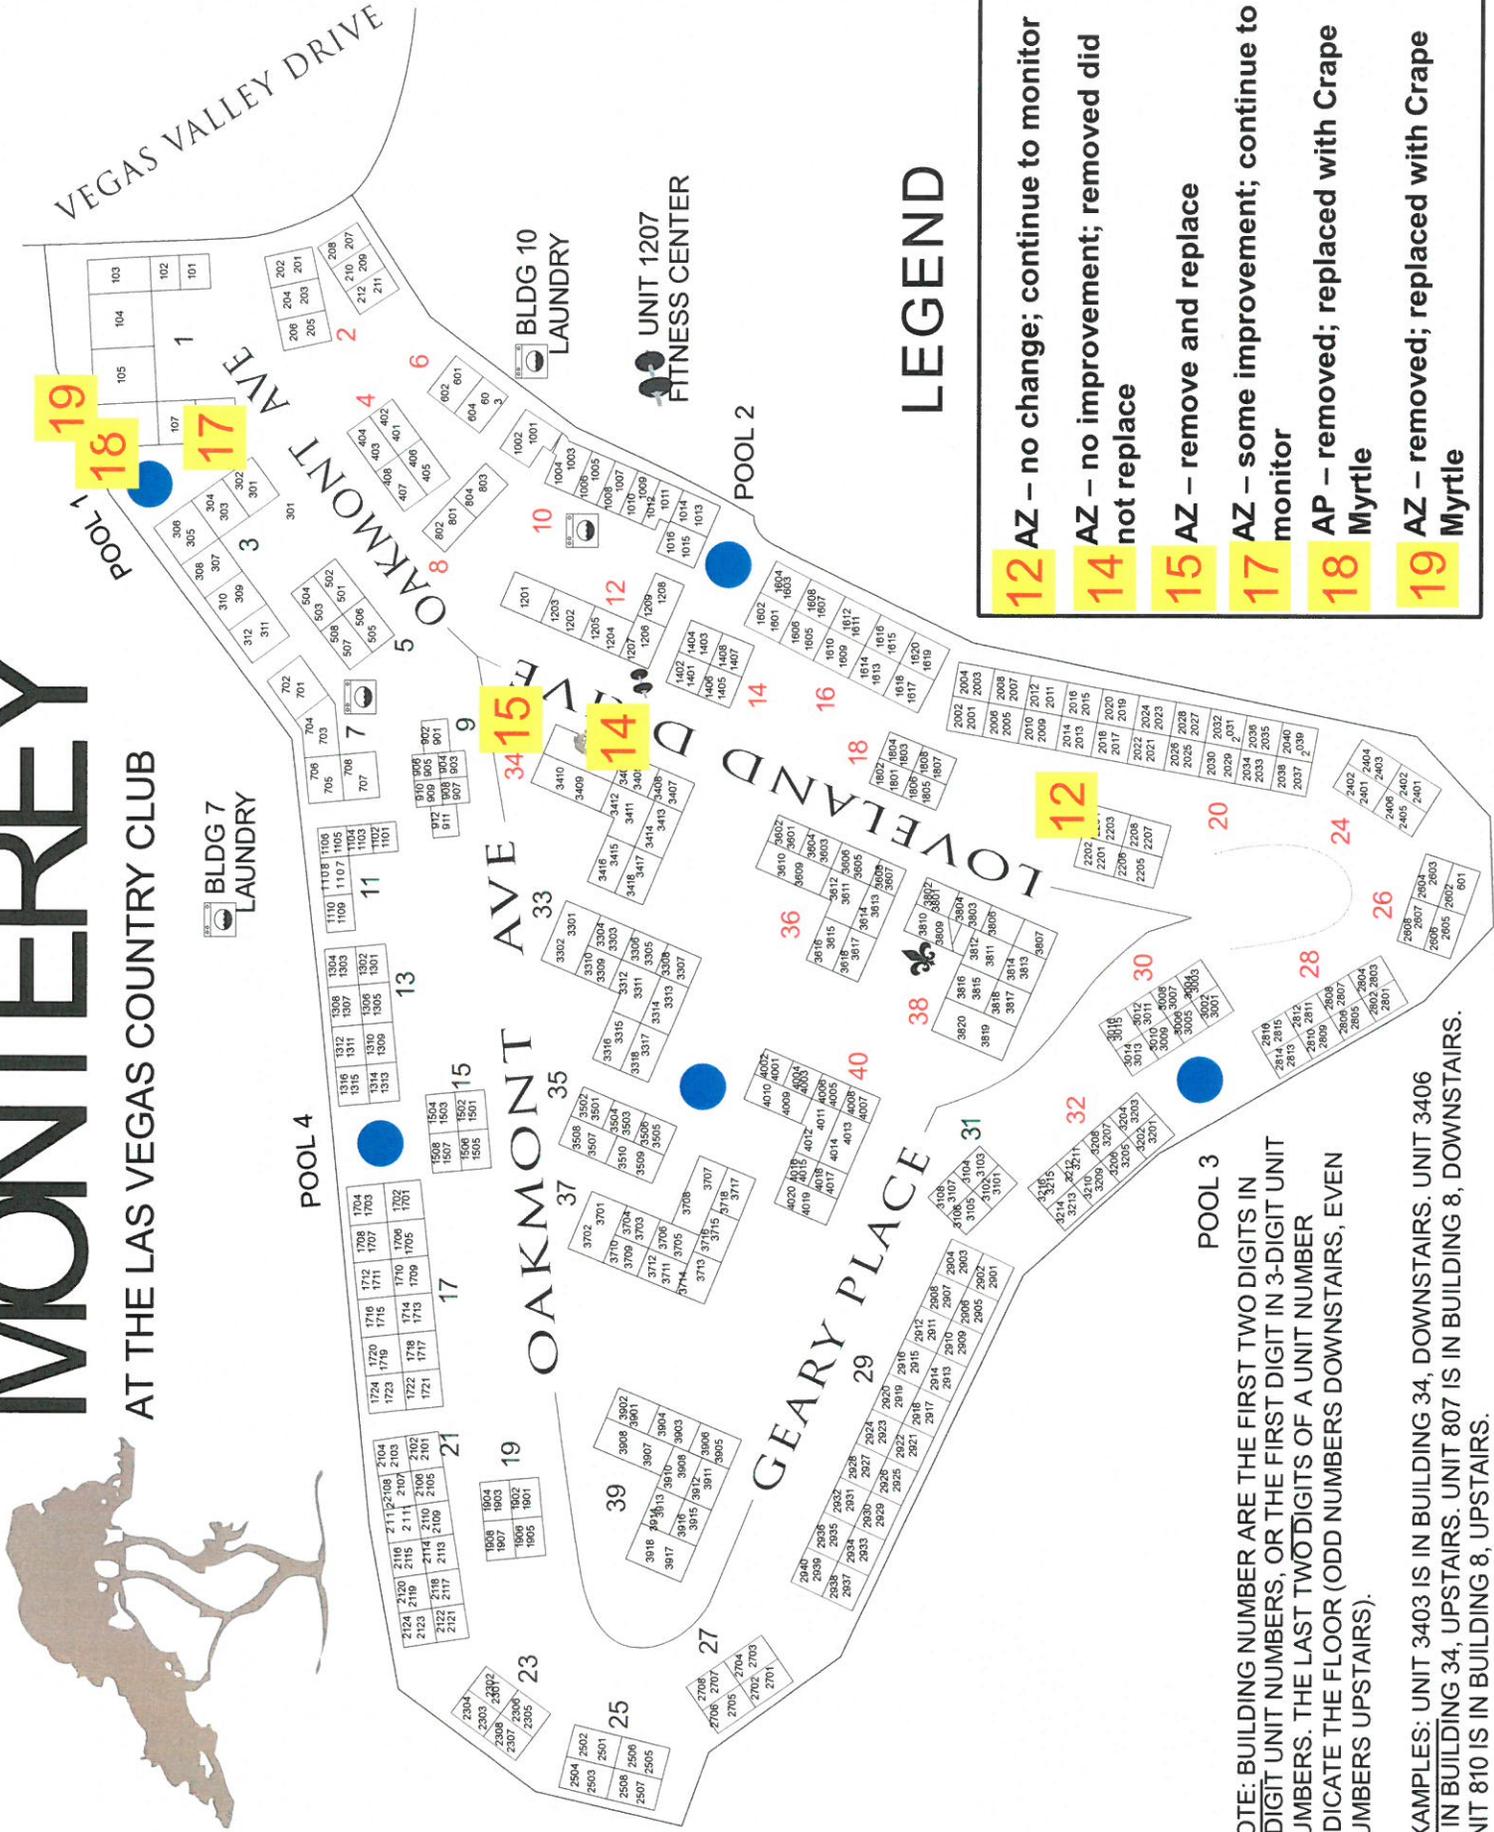
- 12** AZ – no change; continue to monitor
- 14** AZ – no improvement; removed did not replace
- 15** AZ – remove and replace
- 17** AZ – some improvement; continue to monitor
- 18** AP – removed; replaced with Grape Myrtle
- 19** AZ – removed; replaced with Grape Myrtle

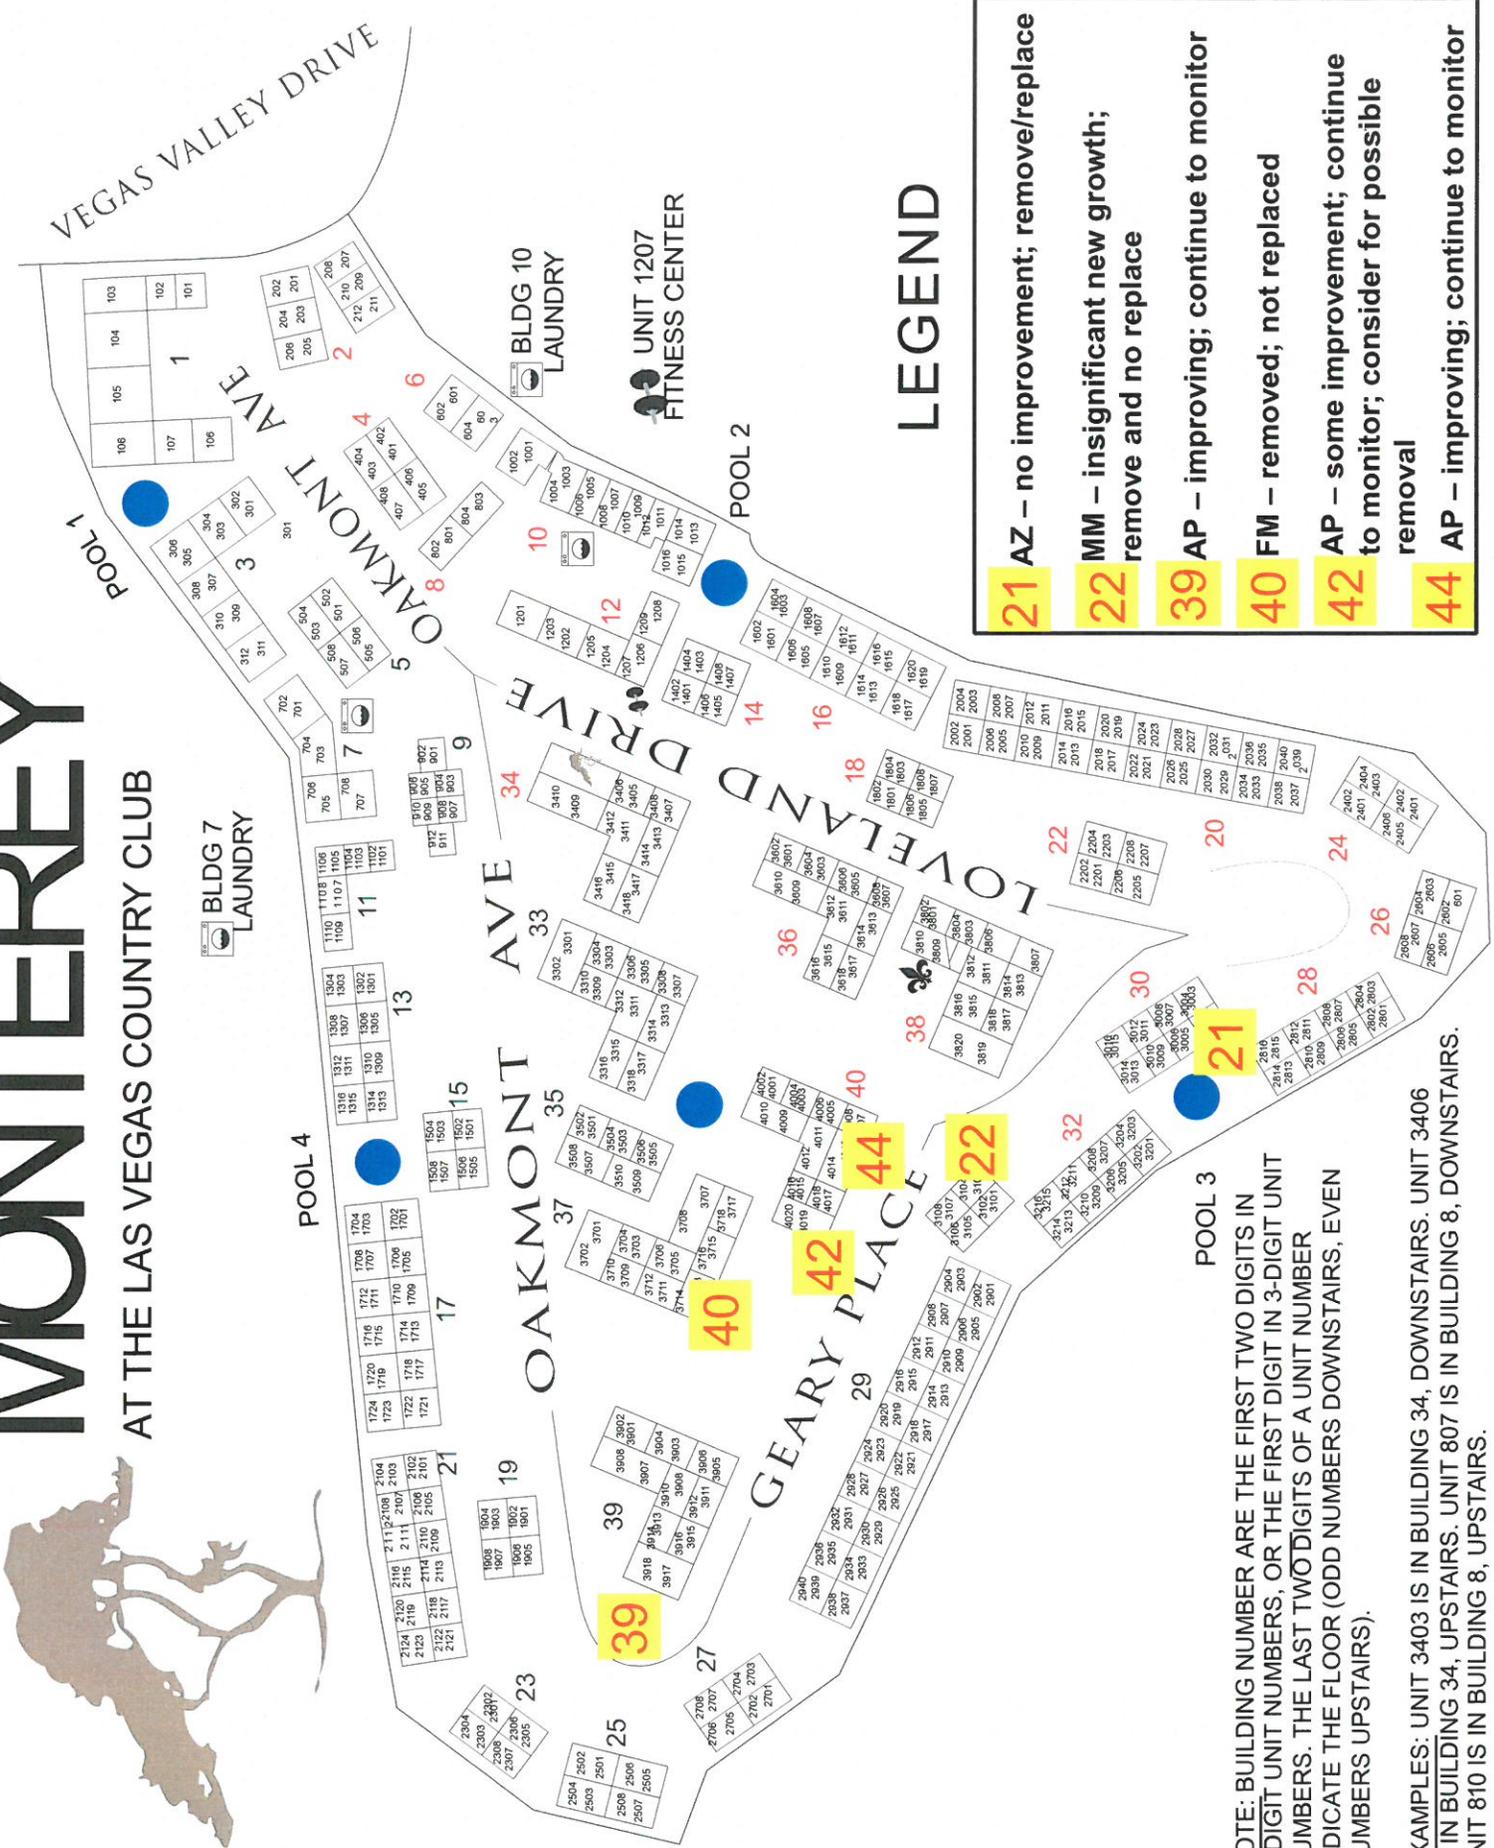
- 21** AZ – no improvement; remove/replace
- 22** MM – insignificant new growth; remove and no replace
- 39** AP – improving; continue to monitor
- 40** FM – removed; not replaced
- 42** AP – some improvement; continue to monitor; consider for possible removal
- 44** AP – improving; continue to monitor

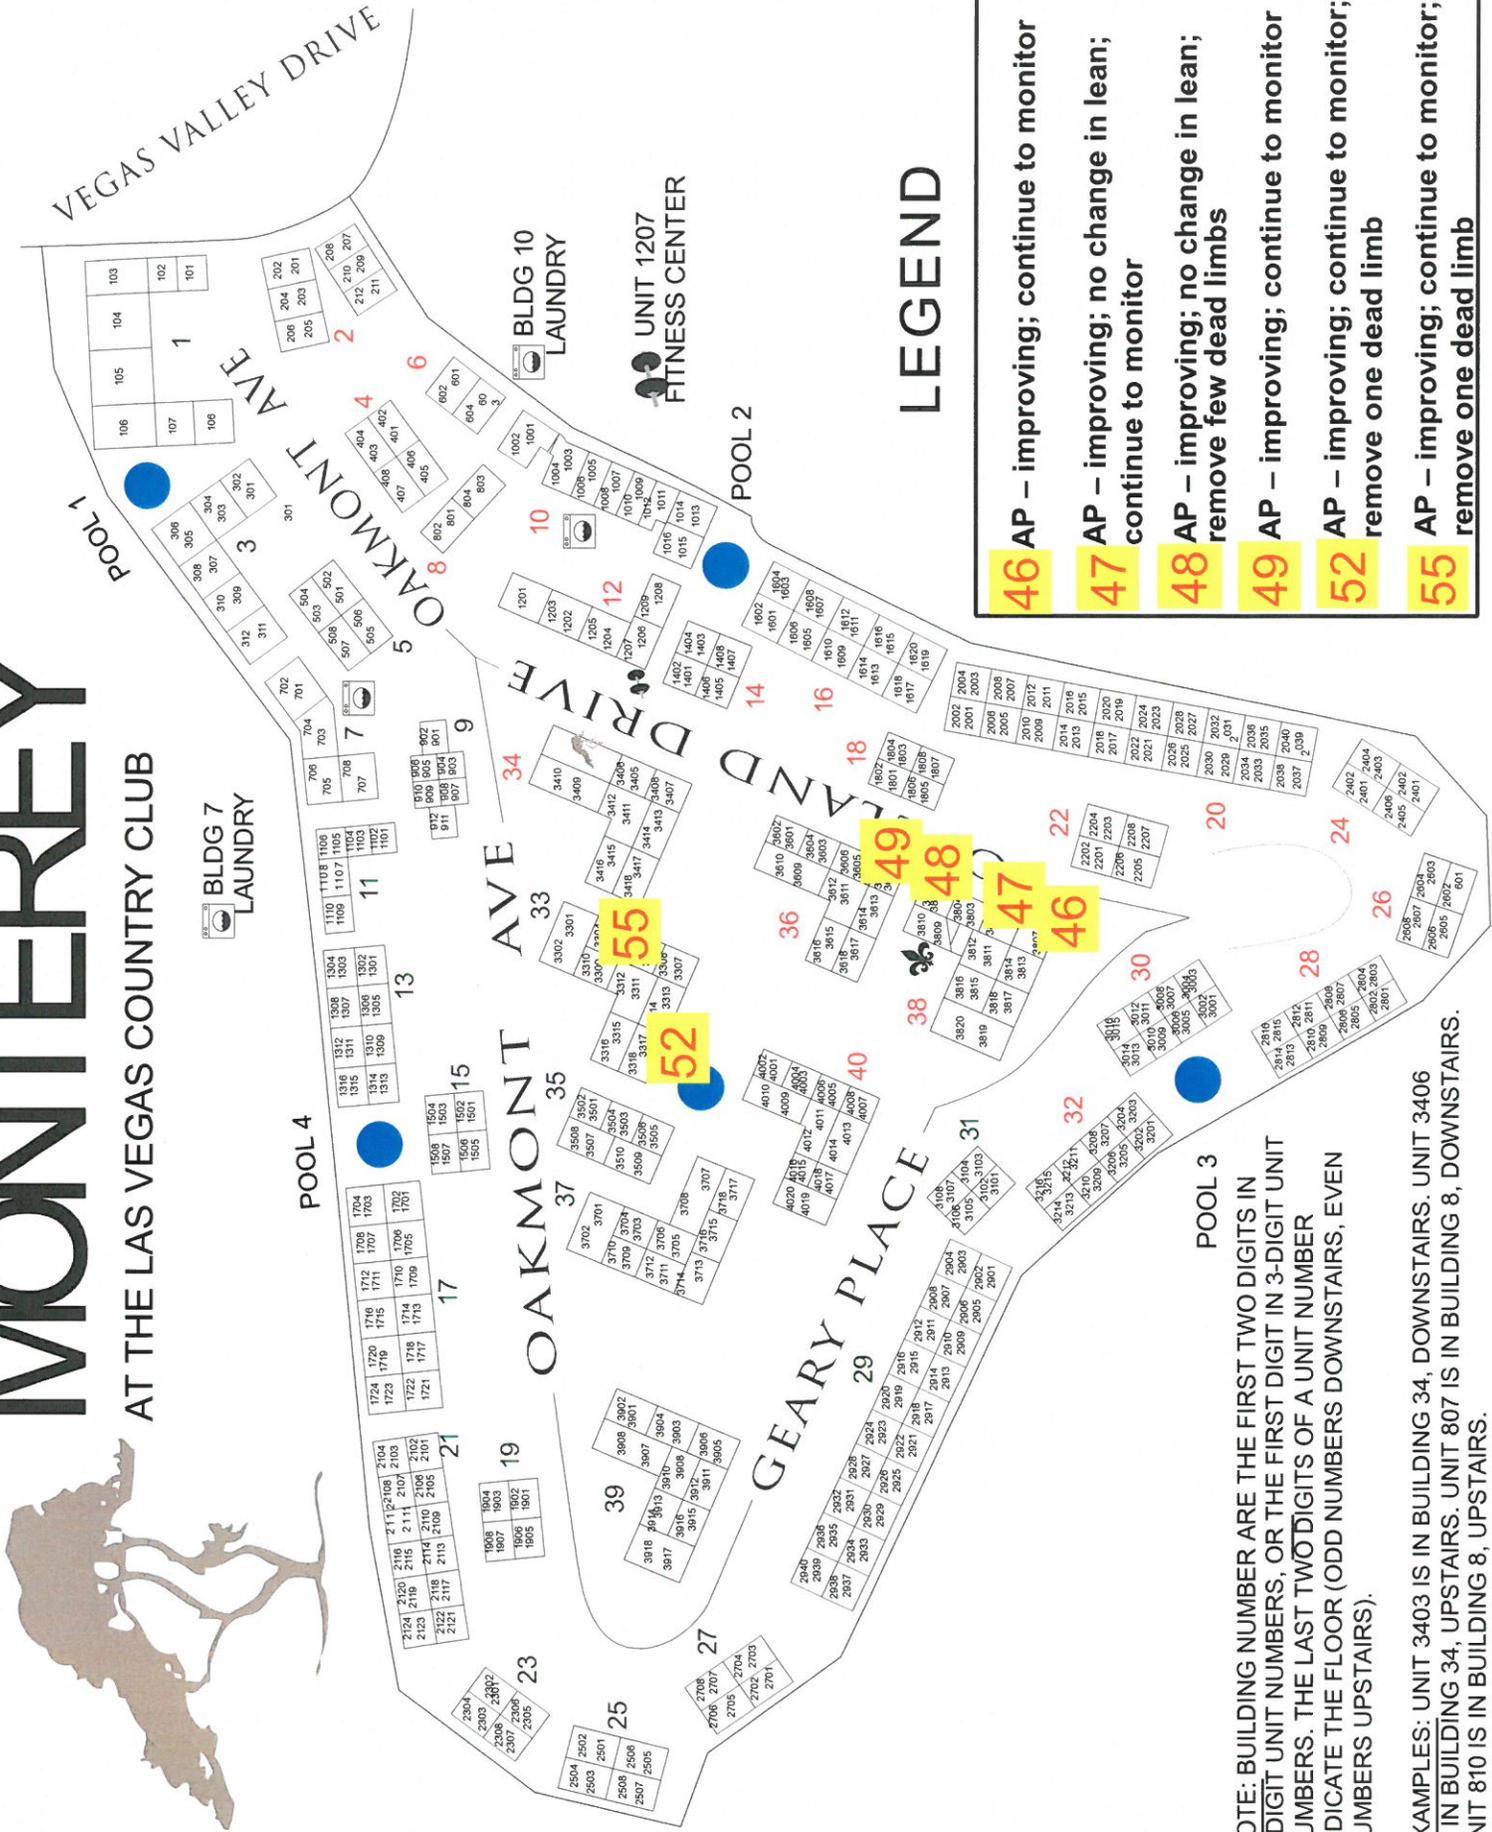
- 46** AP – improving; continue to monitor
- 47** AP – improving; no change in lean; continue to monitor
- 48** AP – improving; no change in lean; remove few dead limbs
- 49** AP – improving; continue to monitor
- 52** AP – improving; continue to monitor; remove one dead limb
- 55** AP – improving; continue to monitor; remove one dead limb

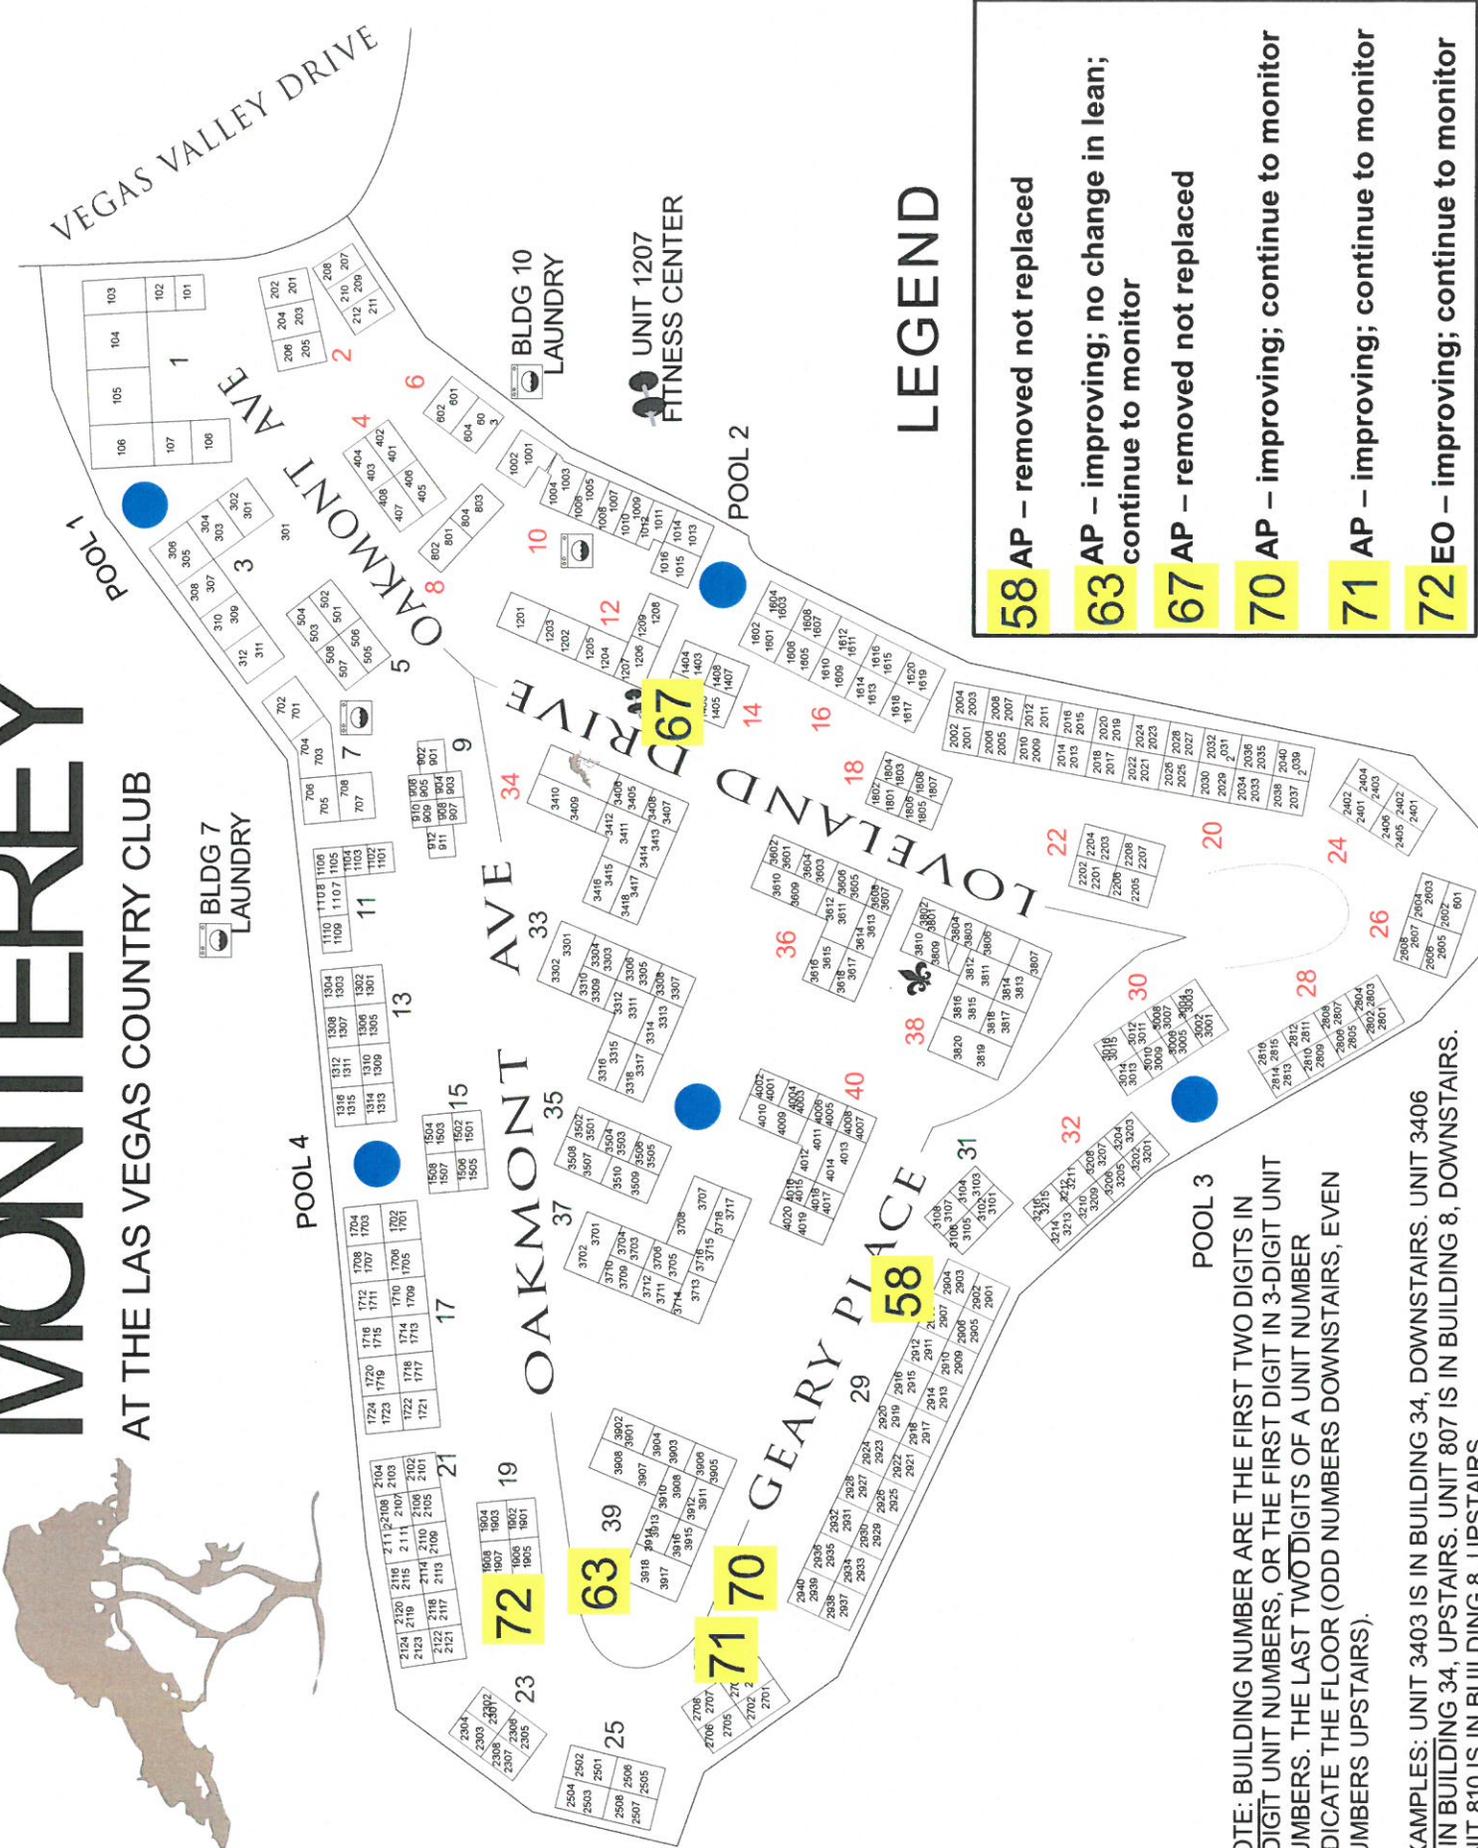
- 58 AP** – removed not replaced
- 63 AP** – improving; no change in lean; continue to monitor
- 67 AP** – removed not replaced
- 70 AP** – improving; continue to monitor
- 71 AP** – improving; continue to monitor
- 72 EO** – improving; continue to monitor

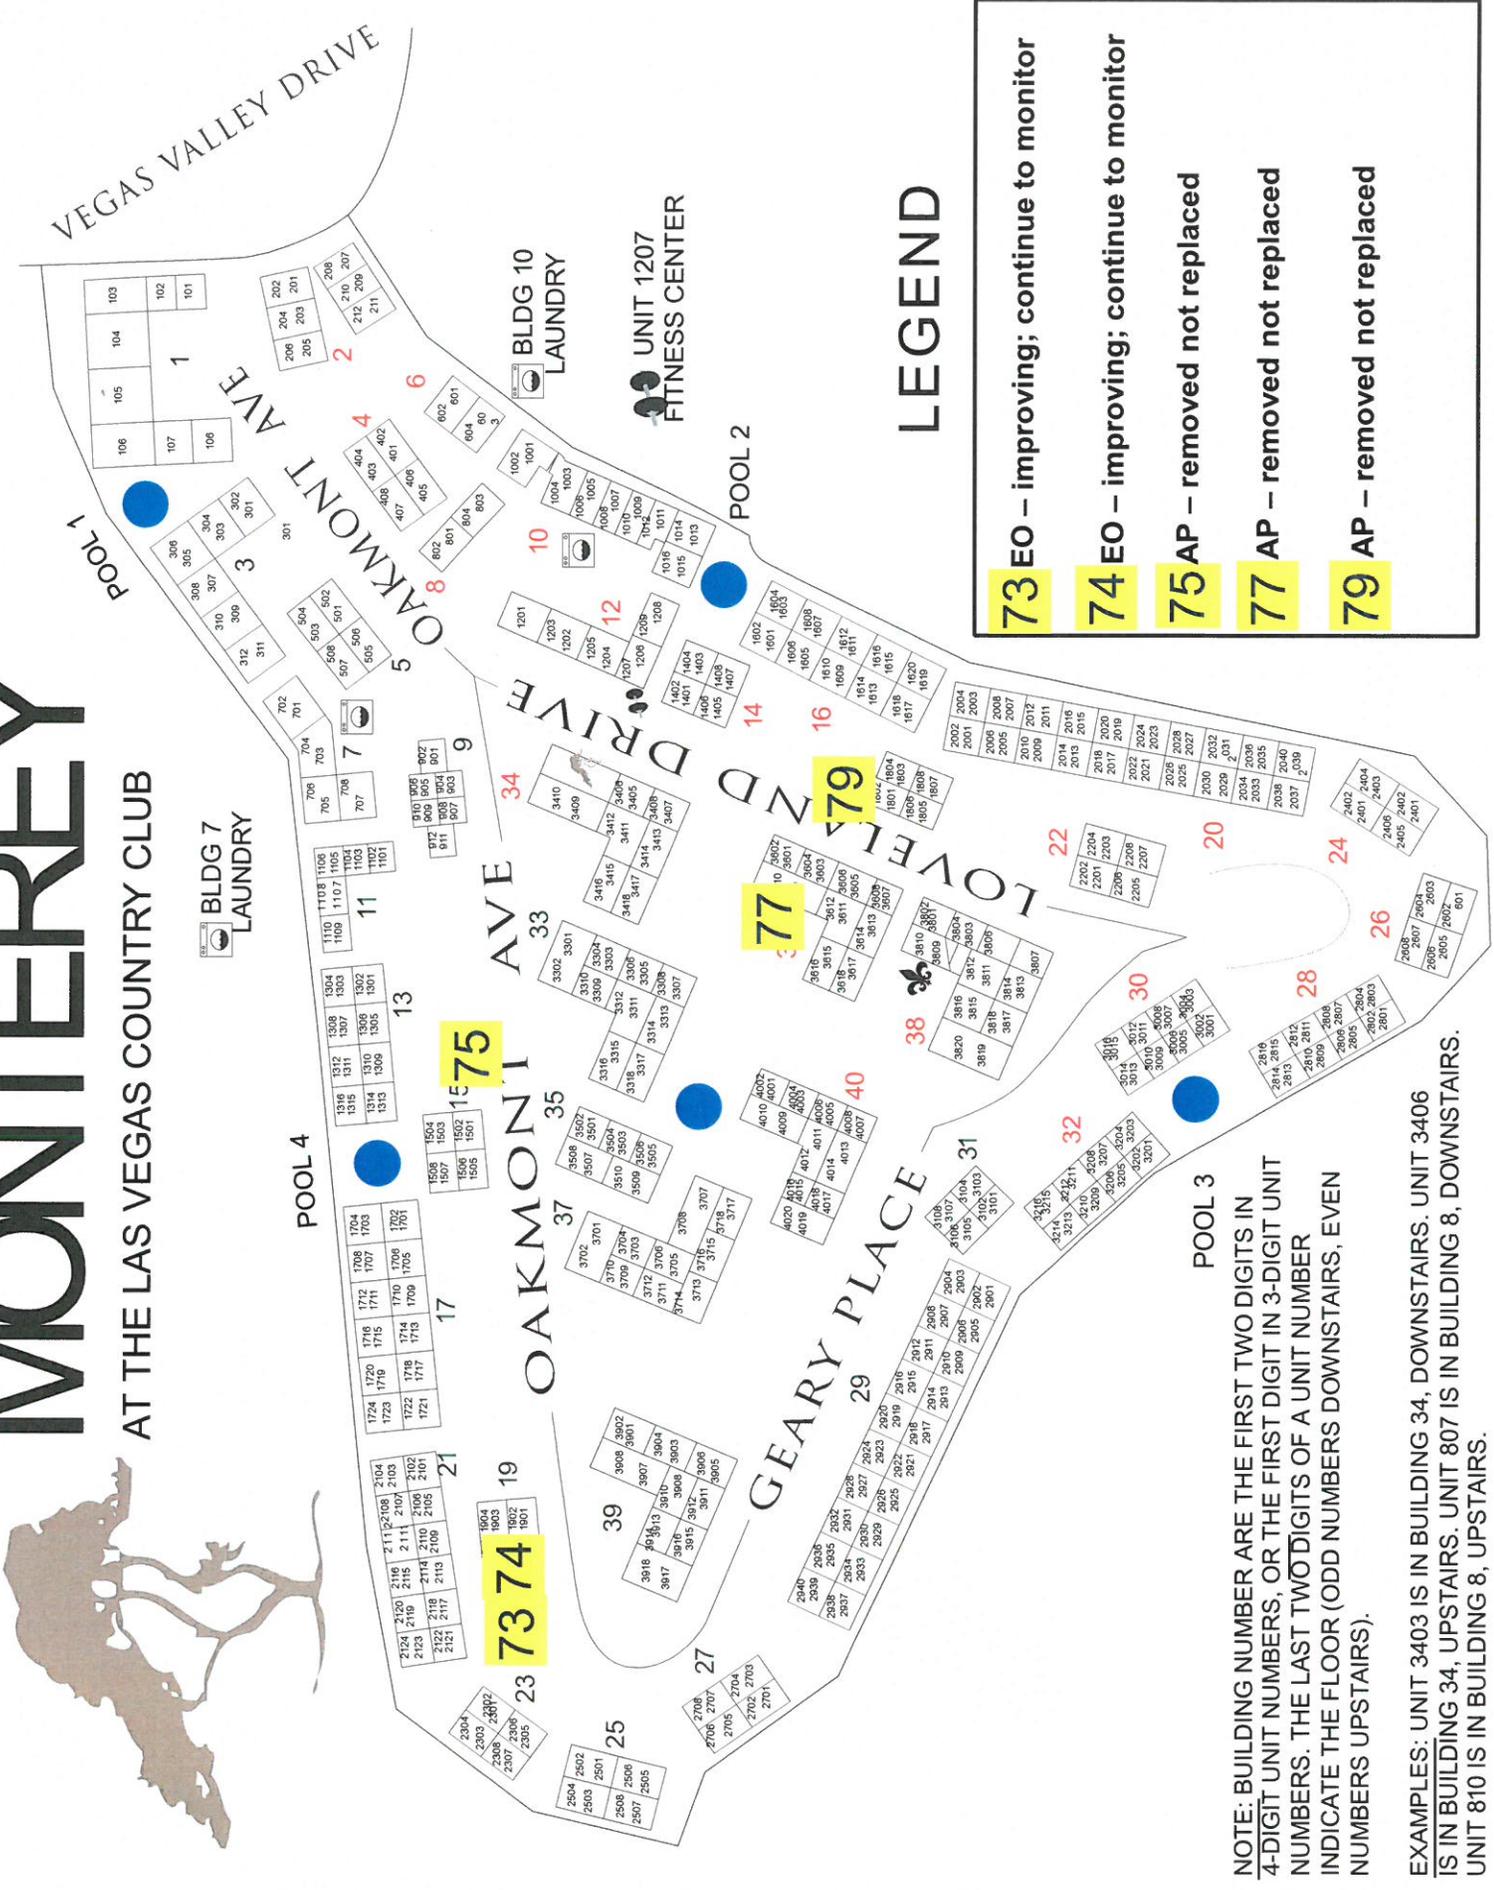
- 73 EO** – improving; continue to monitor
- 74 EO** – improving; continue to monitor
- 75 AP** – removed not replaced
- 77 AP** – removed not replaced
- 79 AP** – removed not replaced

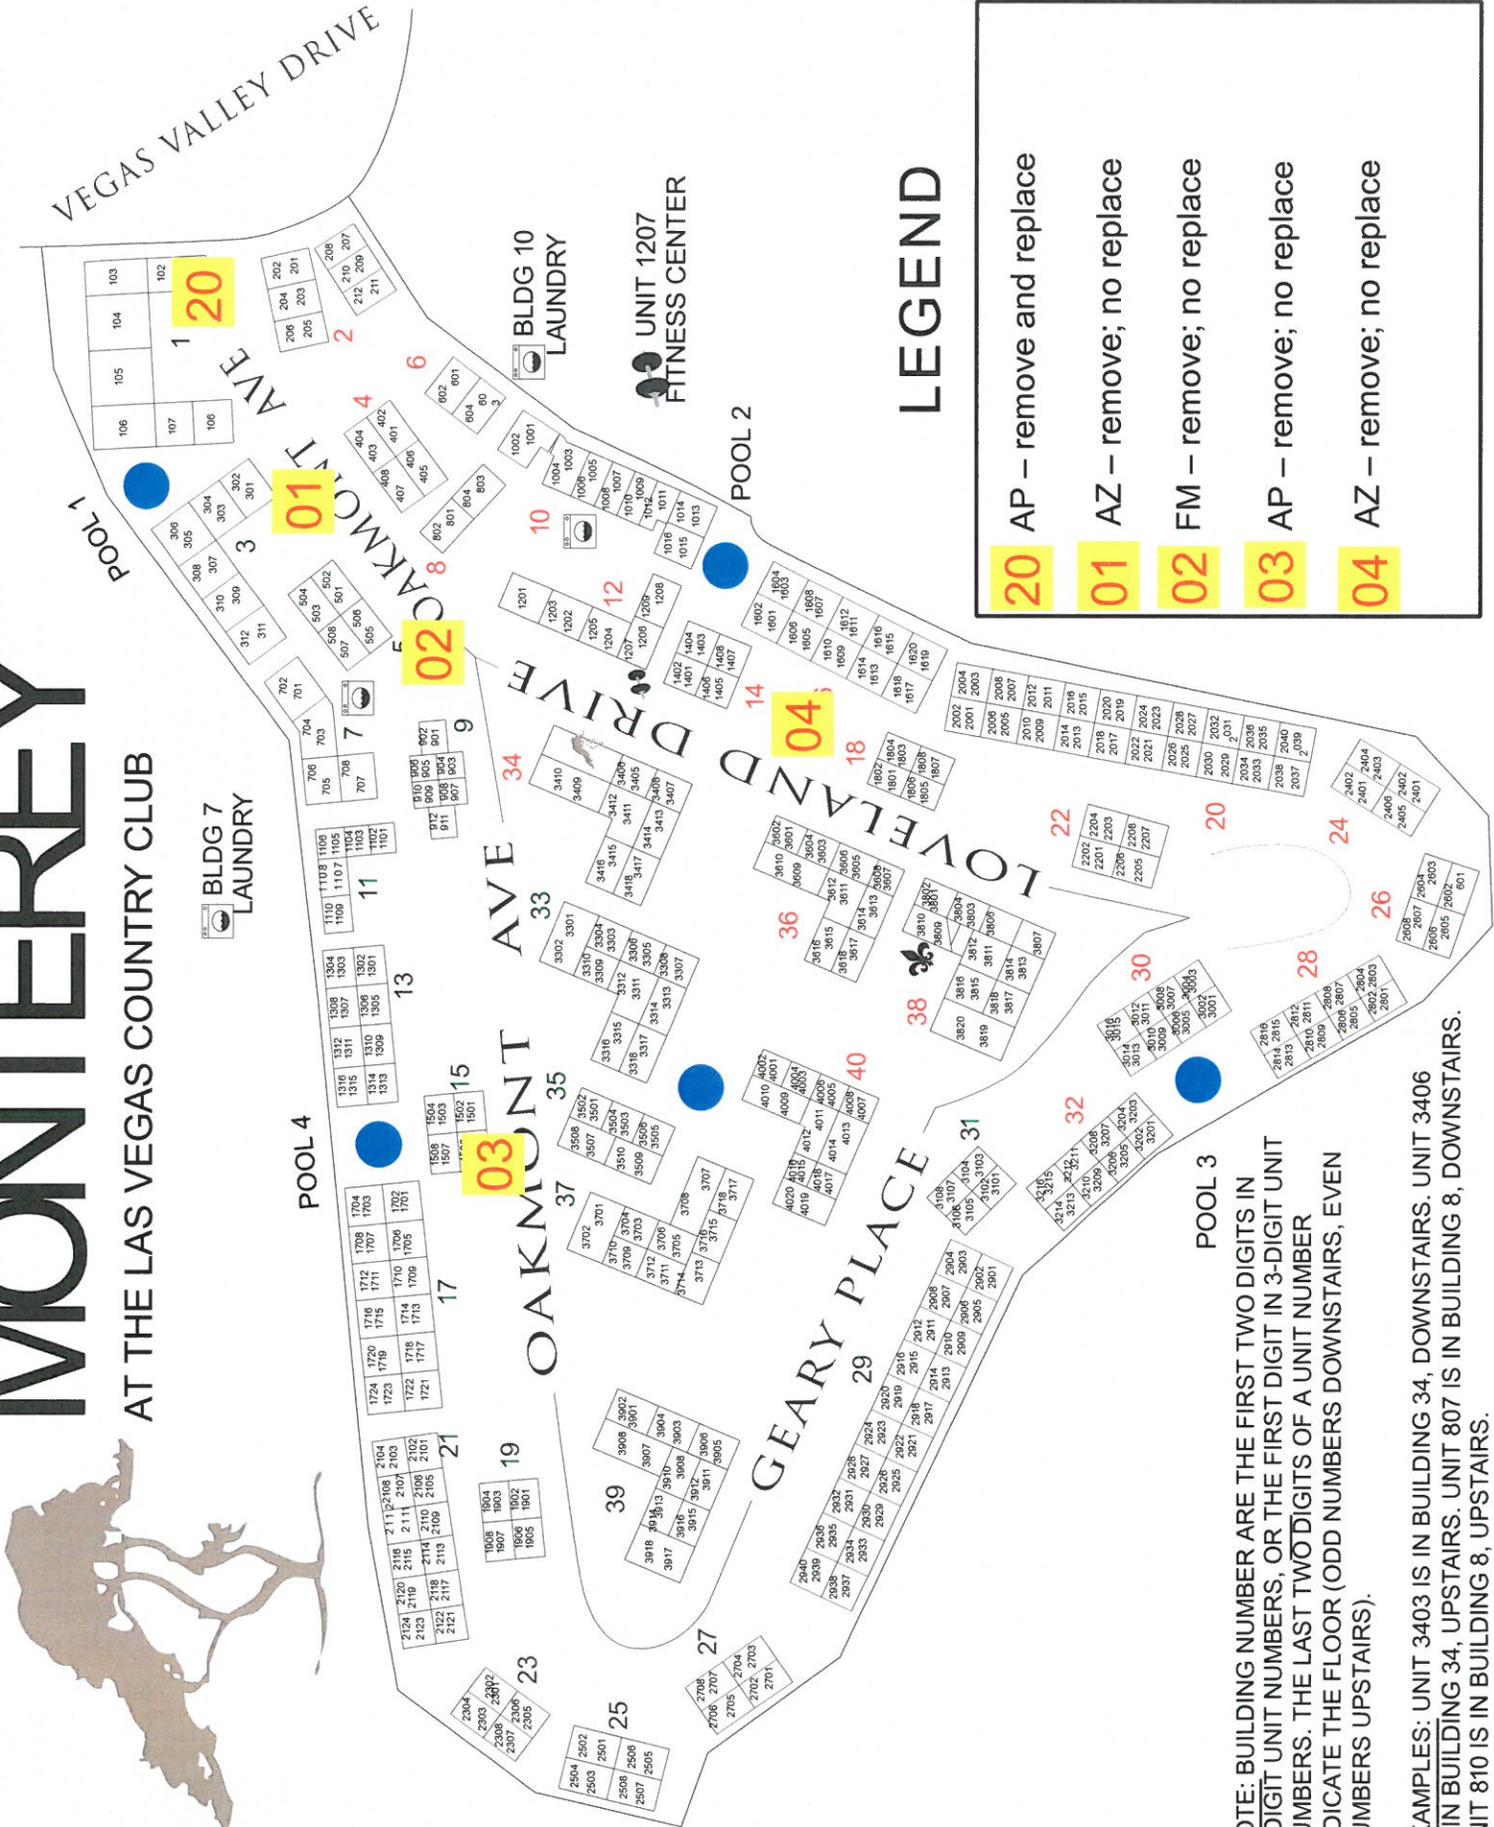
- 20** AP – remove and replace
- 01** AZ – remove; no replace
- 02** FM – remove; no replace
- 03** AP – remove; no replace
- 04** AZ – remove; no replace

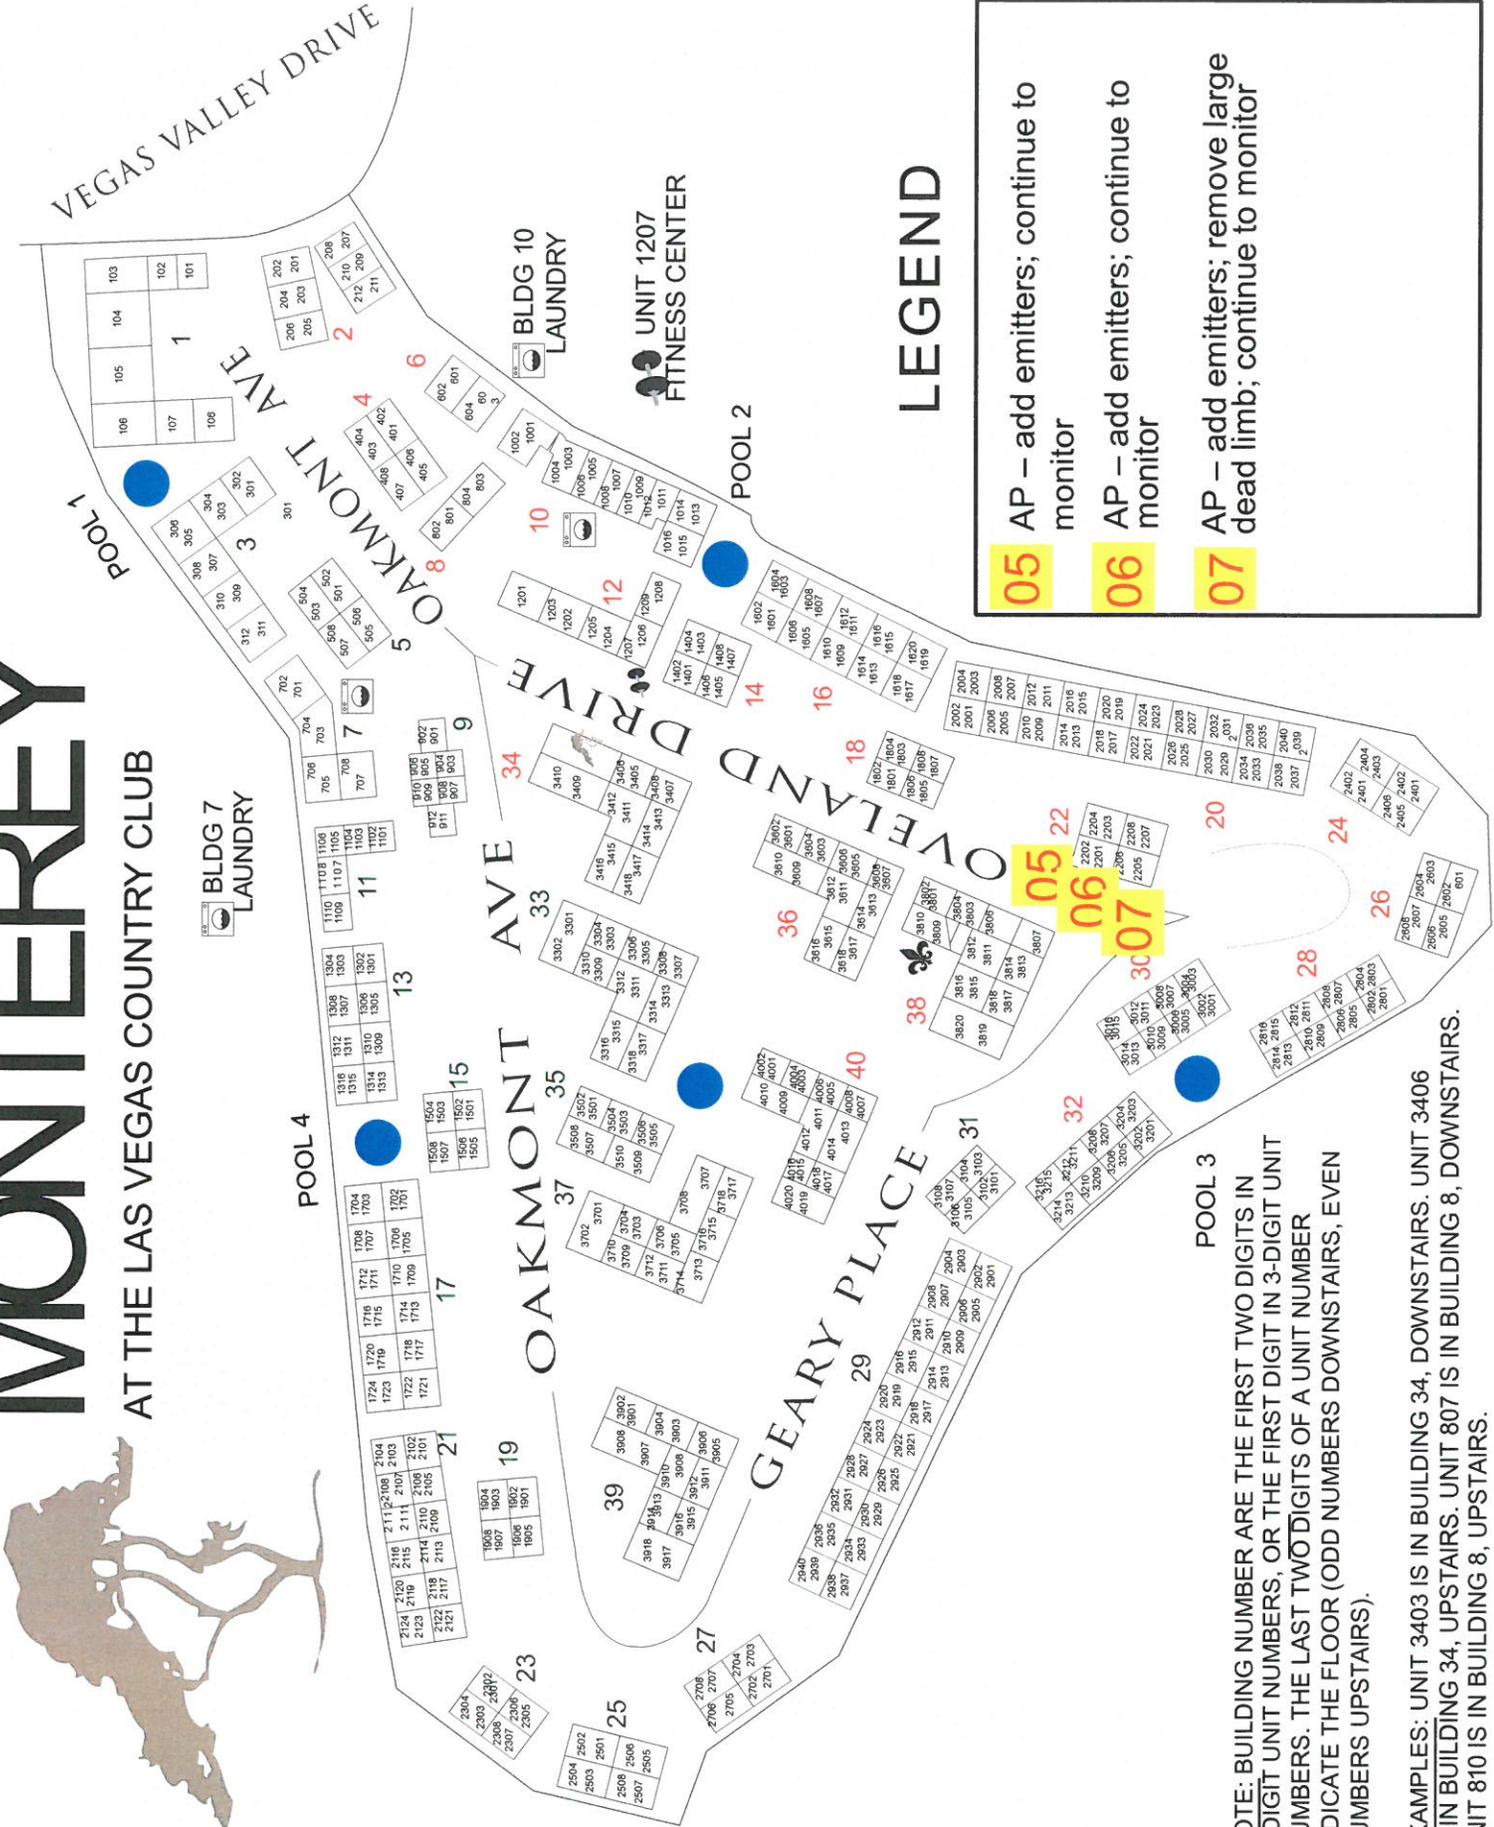
- 05** AP – add emitters; continue to monitor
- 06** AP – add emitters; continue to monitor
- 07** AP – add emitters; remove large dead limb; continue to monitor
